Doc. No. 78-4611-04

Release Notes for the 1600 Series for Cisco IOS Release 11.2P

January 12, 1998

These release notes describe the new features and significant software components for Cisco IOS Release 11.2 P up to and including Release 11.2(11) P for Cisco 1600 series routers.

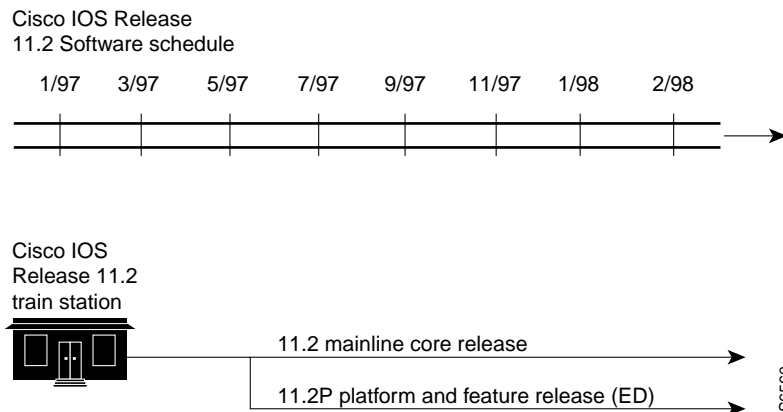
Figure 1 Cisco IOS Release 11.2 Software Releases

Similar to a train rolling down a track and picking up passengers, after a release of Cisco IOS software is released to customers it picks up software fixes along the way and is rereleased as maintenance releases. Maintenance releases provide the most stable software for your network, for the features you need. In addition to the mainline software “train,” there is an early deployment (ED) train. The ED train-Release 11.2 P-delivers fixes to software defects and support for new Cisco platforms and features. Figure 1 shows the Cisco IOS 11.2 and 11.2 P train software releases.
