# Release Notes for Cisco IOS Release 12.2(10)DA2 for Cisco DSLAMs with NI-2

These release notes describe features and caveats in Cisco IOS Release 12.2(10)DA2 for the Cisco 6015, Cisco 6160, and Cisco 6260 digital subscriber line access multiplexers (DSLAMs).

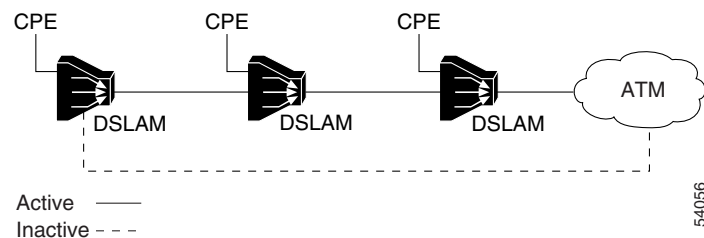
*Figure 1 SPVCs Prior to Failure*

Ring topology is achieved when a node in the subtend tree is attached to the ATM access to provide a physically redundant loop. Thus, when the primary ATM access or one of the ATM trunks in the subtend tree fails, the soft permanent virtual circuits (SPVCs) can be dynamically rerouted through the use of Private Network-Network Interface (PNNI). See [Figure 1](#).

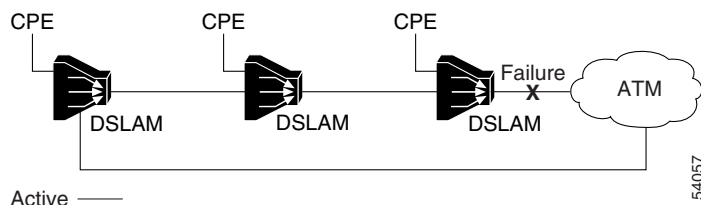
Figure 2 SPVCs Dynamically Rerouted

This redundancy requires the use of SPVCs. If you use permanent virtual circuits (PVCs) or permanent virtual paths (PVPs), redundancy cannot be provided. The use of the SPVCs allows traffic to be rerouted around the failed access point, because SPVCs leverage this feature of PNNI. When the failure occurs, the SPVCs are disconnected and dynamically reconnected across the new path. See [Figure 2](#).
