Release Notes for Cisco IOS Release 12.2(10)DA3 for Cisco DSLAMs with NI-2

These release notes describe features and caveats in Cisco IOS Release 12.2(10)DA3 for the Cisco 6015, Cisco 6160, and Cisco 6260 digital subscriber line access multiplexers (DSLAMs).

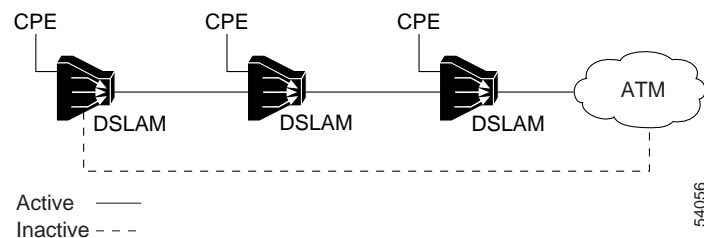
Figure 1 SPVCs Prior to Failure

Ring topology is achieved when a node in the subtend tree is attached to the ATM access to provide a physically redundant loop. Thus, when the primary ATM access or one of the ATM trunks in the subtend tree fails, the soft permanent virtual circuits (SPVCs) can be dynamically rerouted through the use of Private Network-Network Interface (PNNI). See [Figure 1](#).

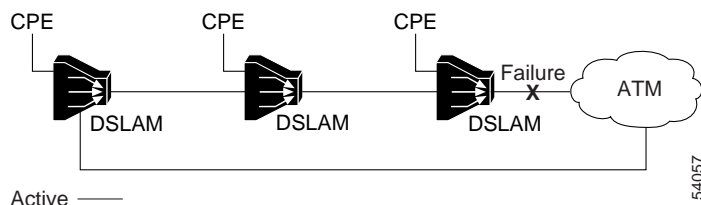
Figure 2 *SPVCs Dynamically Rerouted*

This redundancy requires the use of SPVCs. If you use permanent virtual circuits (PVCs) or permanent virtual paths (PVPs), redundancy cannot be provided. The use of the SPVCs allows traffic to be rerouted around the failed access point, because SPVCs leverage this feature of PNNI. When the failure occurs, the SPVCs are disconnected and dynamically reconnected across the new path. See [Figure 2](#).
