Release Notes for Cisco IOS Release 12.2(10)DA5 for Cisco DSLAMs with NI-2

These release notes describe features and caveats in Cisco IOS Release 12.2(10)DA5 for the Cisco 6015, Cisco 6160, and Cisco 6260 digital subscriber line access multiplexers (DSLAMs).

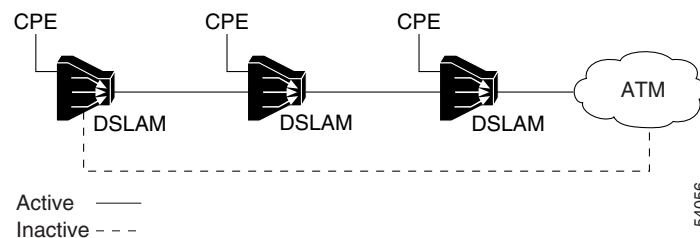
Figure 1 SPVCs Prior to Failure

Ring topology is achieved when a node in the subtend tree is attached to the ATM access to provide a physically redundant loop. Thus, when the primary ATM access or one of the ATM trunks in the subtend tree fails, the soft permanent virtual circuits (SPVCs) can be dynamically rerouted through the use of Private Network-Network Interface (PNNI). See [Figure 1](#).
