Release Notes for Cisco IOS Release 12.2(10)DA6 for Cisco DSLAMs with NI-2

These release notes describe features and caveats in Cisco IOS Release 12.2(10)DA6 for the Cisco 6015, Cisco 6160, and Cisco 6260 digital subscriber line access multiplexers (DSLAMs).

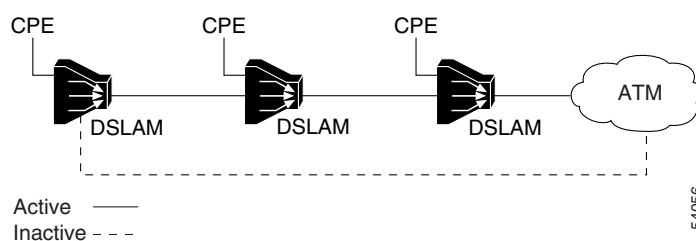
Figure 1 SPVCs Prior to Failure

Ring topology is achieved when a node in the subtend tree is attached to the ATM access to provide a physically redundant loop. Thus, when the primary ATM access or one of the ATM trunks in the subtend tree fails, the soft permanent virtual circuits (SPVCs) can be dynamically rerouted through the use of Private Network-Network Interface (PNNI). See [Figure 1](#).

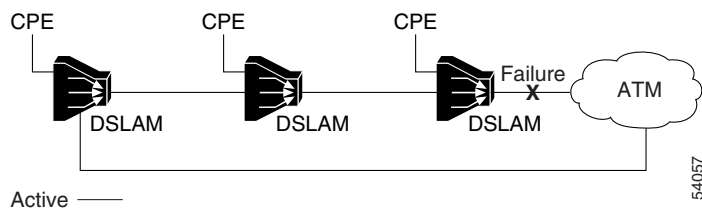
Figure 2 *SPVCs Dynamically Rerouted*

This redundancy requires the use of SPVCs. If you use permanent virtual circuits (PVCs) or permanent virtual paths (PVPs), redundancy cannot be provided. The use of the SPVCs allows traffic to be rerouted around the failed access point, because SPVCs leverage this feature of PNNI. When the failure occurs, the SPVCs are disconnected and dynamically reconnected across the new path. See [Figure 2](#).

- You must use SPVCs, PNNI, ATM signaling, and Interim Local Management Interface (ILMI) to enable rerouting. PNNI, ATM signaling, and ILMI are enabled by default. Permanent connections such as PVCs and shaped virtual paths (VPs) do not benefit from the redundant link.
- You must make the redundant link’s PNNI administrative weight higher than the PNNI weight of the primary trunk. Once you change the weight of the redundant link, the subtend tree uses this link only if a failure occurs.
