# Release Notes for Cisco IOS Release 12.2(10)DA7 for Cisco DSLAMs with NI-2

These release notes describe features and caveats in Cisco IOS Release 12.2(10)DA7 for the Cisco 6015, Cisco 6160, and Cisco 6260 digital subscriber line access multiplexers (DSLAMs).

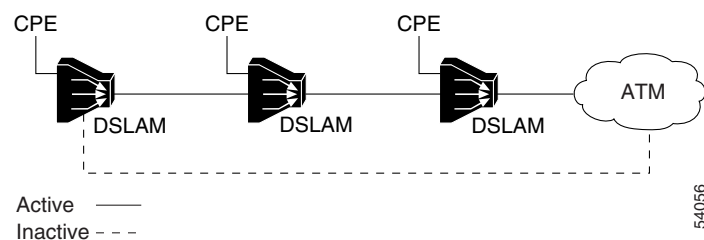
*Figure 1 SPVCs Prior to Failure*

Ring topology is achieved when a node in the subtend tree is attached to the ATM access to provide a physically redundant loop. Thus, when the primary ATM access or one of the ATM trunks in the subtend tree fails, the soft permanent virtual circuits (SPVCs) can be dynamically rerouted through the use of Private Network-Network Interface (PNNI). See [Figure 1](#).
