Release Notes for Cisco IOS Release 12.2(10)DA8 for Cisco DSLAMs with NI-2

These release notes describe features and caveats in Cisco IOS Release 12.2(10)DA8 for the Cisco 6015, Cisco 6160, and Cisco 6260 digital subscriber line access multiplexers (DSLAMs).

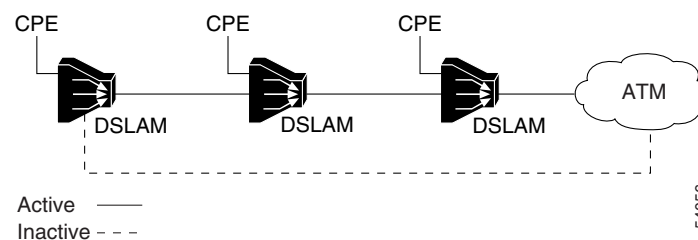
Figure 1 SPVCs Prior to Failure

Ring topology is achieved when a node in the subtend tree is attached to the ATM access to provide a physically redundant loop. Thus, when the primary ATM access or one of the ATM trunks in the subtend tree fails, the soft permanent virtual circuits (SPVCs) can be dynamically rerouted through the use of Private Network-Network Interface (PNNI). See [Figure 1](#).

If you implement ring topology in a DSLAM subtend to achieve ATM trunk redundancy, the following requirements apply:

- You must use SPVCs, PNNI, ATM signaling, and Interim Local Management Interface (ILMI) to enable rerouting. PNNI, ATM signaling, and ILMI are enabled by default. Permanent connections such as PVCs and shaped virtual paths (VPs) do not benefit from the redundant link.
- You must make the redundant link's PNNI administrative weight higher than the PNNI weight of the primary trunk. Once you change the weight of the redundant link, the subtend tree uses this link only if a failure occurs.
