Release Notes for Cisco IOS Release 12.2(10)DA1 for Cisco DSLAMs with NI-2

These release notes describe features and caveats in Cisco IOS Release 12.2(10)DA1 for the Cisco 6015, Cisco 6160, and Cisco 6260 digital subscriber line access multiplexers (DSLAMs).

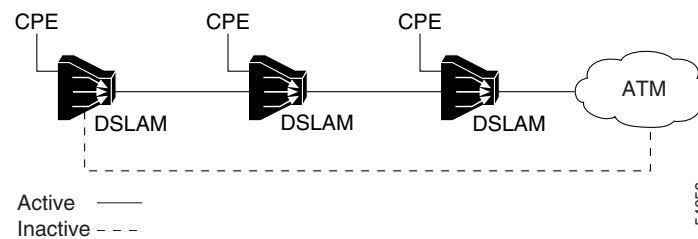
Figure 1 SPVCs Prior to Failure

Ring topology is achieved when a node in the subtend tree is attached to the ATM access to provide a physically redundant loop. Thus, when the primary ATM access or one of the ATM trunks in the subtend tree fails, the soft permanent virtual circuits (SPVCs) can be dynamically rerouted through the use of Private Network-Network Interface (PNNI). See [Figure 1](#).

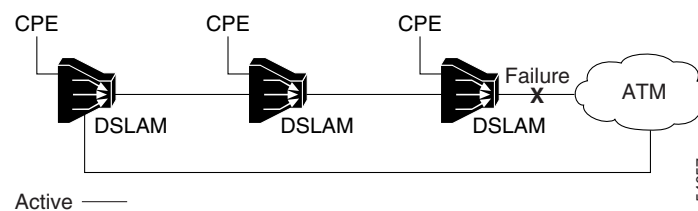
Figure 2 SPVCs Dynamically Rerouted

This redundancy requires the use of SPVCs. If you use permanent virtual circuits (PVCs) or permanent virtual paths (PVPs), redundancy cannot be provided. The use of the SPVCs allows traffic to be rerouted around the failed access point, because SPVCs leverage this feature of PNNI. When the failure occurs, the SPVCs are disconnected and dynamically reconnected across the new path. See [Figure 2](#).
