Release Notes for Cisco IOS Release 12.2(12)DA1 for Cisco DSLAMs with NI-2 Cards

These release notes describe features and caveats in Cisco IOS Release 12.2(12)DA1 for the Cisco 6015, Cisco 6160, and Cisco 6260 digital subscriber line access multiplexers (DSLAMs).

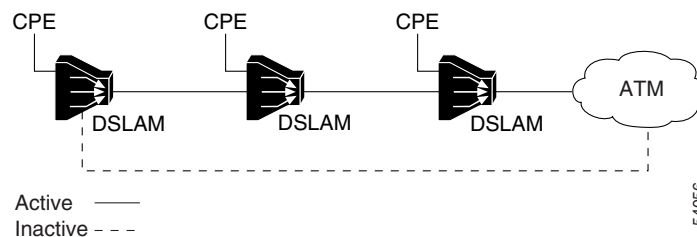
Figure 1 SPVCs Prior to Failure

Ring topology is achieved when a node in the subtend tree is attached to the ATM access to provide a physically redundant loop. Thus, when the primary ATM access or one of the ATM trunks in the subtend tree fails, the soft permanent virtual circuits (SPVCs) can be dynamically rerouted through the use of Private Network-Network Interface (PNNI) (Figure 1).

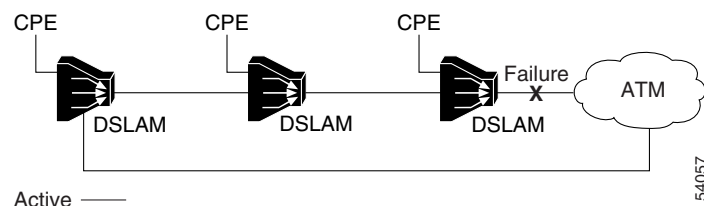
Figure 2 SPVCs Dynamically Rerouted

This redundancy requires the use of SPVCs. If you use permanent virtual circuits (PVCs) or permanent virtual paths (PVPs), redundancy cannot be provided. The use of the SPVCs allows traffic to be rerouted around the failed access point, because SPVCs leverage this feature of PNNI. When the failure occurs, the SPVCs are disconnected and dynamically reconnected across the new path (Figure 2).
