## Upgrade Cards and Spans

This chapter explains how to upgrade cross-connect cards and optical spans (speeds) within a ring or protection group for the Cisco ONS 15454 SDH.

### NTP-D92 Upgrade the XC10G Card to the XC-VXL-2.5G or XC-VXL-10G Card

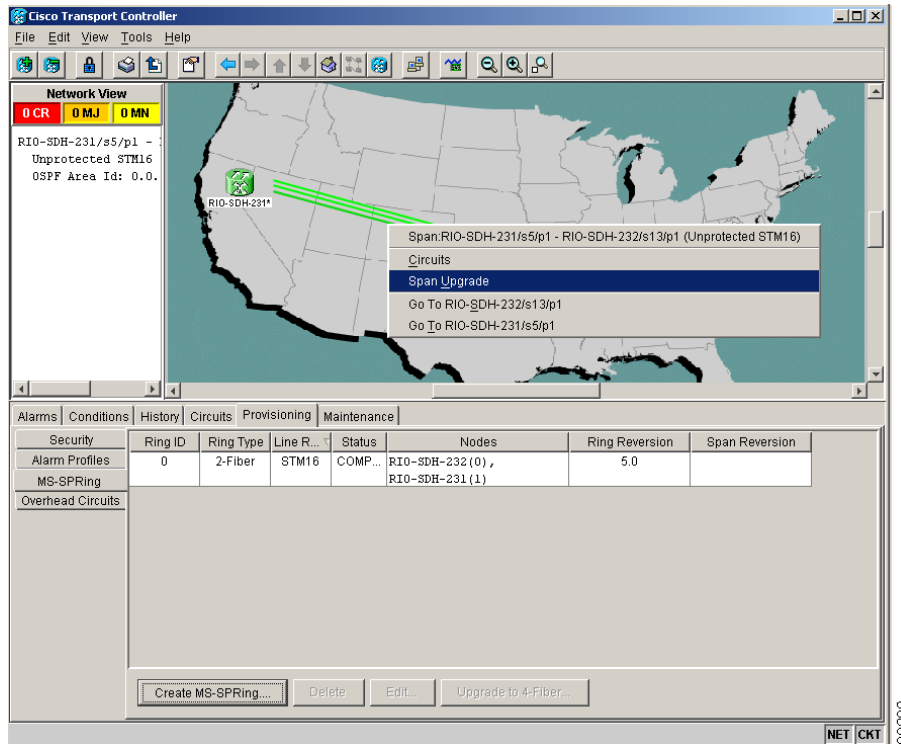
**Figure 12-1** Span Upgrade Shortcut Menu

**Step 5** Choose **Span Upgrade** from the shortcut menu (Figure 12-1).

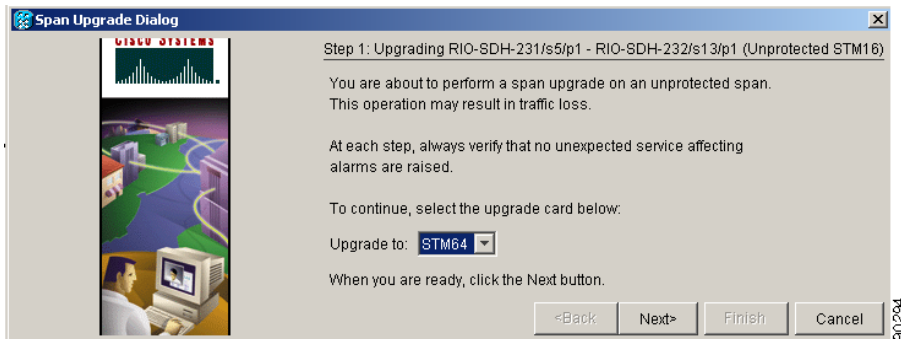
**Figure 12-2** Span Upgrade Wizard

**Step 6** The first Span Upgrade dialog box appears (Figure 12-2). Follow the instructions in the dialog box and the wizard will lead you through the rest of the span upgrade.

**Note** The Back button is only enabled on Step 2 of the wizard; because you cannot back out of an upgrade via the wizard, close the wizard and initiate the manual procedure if you need to back out of the upgrade at any point beyond Step 2.
