## Alarm Troubleshooting

This chapter gives a description, severity, and troubleshooting procedure for each commonly encountered Cisco DWDM alarm and condition. Tables [Table 1: Critical DWDM Alarm List, on page 2](#) through [Table 5: NR DWDM Conditions List, on page 12](#) provide lists of DWDM alarms organized by severity. [Table 7: Alarm Logical Object Type Definitions, on page 23](#) provides a list of alarms organized alphabetically. [Table 7: Alarm Logical Object Type Definitions, on page 23](#) gives definitions of all DWDM alarm logical objects, which are the basis of the alarm profile list in [Table 8: Alarm List by Logical Object in Alarm Profile, on page 24](#). For a comprehensive list of all conditions and instructions for using TL1 commands, refer to the *Cisco ONS SONET TL1 Command Guide*. An alarm troubleshooting procedure applies to both the Cisco Transport Controller (CTC) and TL1 version of that alarm.

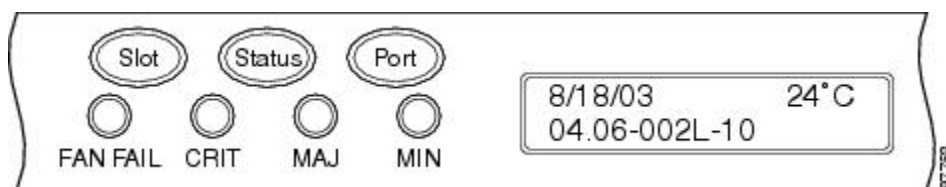
**Figure 1: Shelf LCD Panel**

- Step 1** View the temperature displayed on the ONS 15454 LCD front panel (Figure 2: Shelf LCD Panel, on page 131).

Figure 2: Shelf LCD Panel, on page 131 shows the shelf LCD panel.

- Step 1** View the temperature displayed on the ONS system LCD front panel. For example, the ONS 15454 front panel is illustrated in [Figure 2: Shelf LCD Panel](#), on page 131.

- 
- Step 1** Check for any outstanding alarms that were raised against the active and standby TCC2/TCC2P/TCC3 and resolve them.
- Step 2** If the alarm does not clear, determine whether the LCD display on the fan tray ([Figure 2: Shelf LCD Panel, on page 131](#)) is blank or if the text is garbled. If so, proceed to [Step 8, on page 146](#). If not, continue with [Step 3, on page 145](#).
