# Release Notes for Cisco SN 5428 Storage Router Release 2.3.1

These release notes support Cisco SN 5428 Storage Router software release 2.3.1.

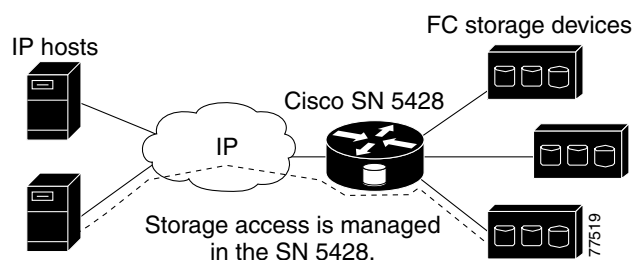
**Figure 1** *iSCSI Routing*

SCSI routing provides IP hosts with access to Fibre Channel (FC) storage devices, using iSCSI protocol.

With SCSI routing, storage device access is managed primarily in the SN 5428. (See [Figure 1](#).)

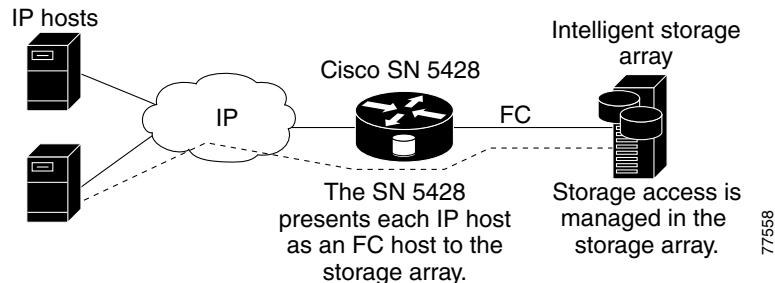
**Figure 2** *Transparent SCSI Routing*

Transparent SCSI routing provides IP hosts with transparent access to intelligent storage arrays using iSCSI protocol; that is, each IP host is presented as an FC host to an intelligent storage array. With transparent SCSI routing, availability of storage devices is managed primarily in the intelligent storage array. (See [Figure 2](#).)
