Release Notes for Cisco SN 5428 Storage Router Release 2.5.1

These release notes support Cisco SN 5428 Storage Router software release 2.5.1.

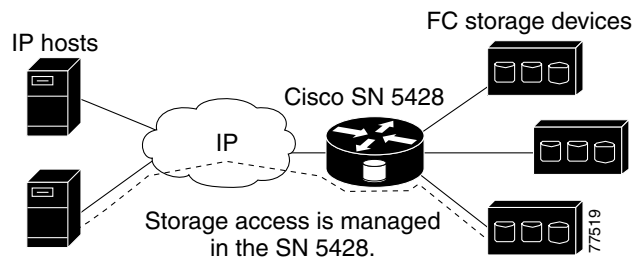
Figure 1 *SCSI Routing*

With SCSI routing, storage device access is managed primarily in the SN 5428. (See [Figure 1](#).)

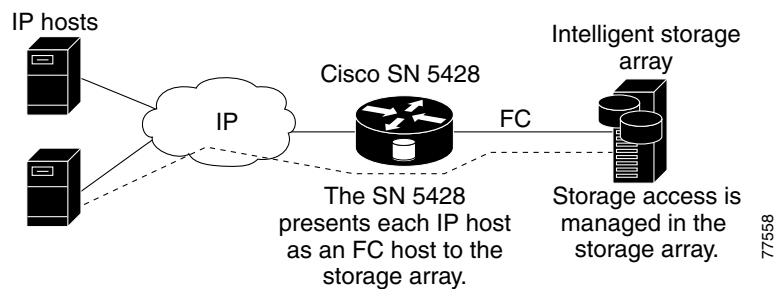
Figure 2 *Transparent SCSI Routing*

Transparent SCSI routing provides IP hosts with transparent access to intelligent storage arrays using iSCSI protocol; that is, each IP host is presented as an FC host to an intelligent storage array. With transparent SCSI routing, availability of storage devices is managed primarily in the intelligent storage array. (See [Figure 2](#).)

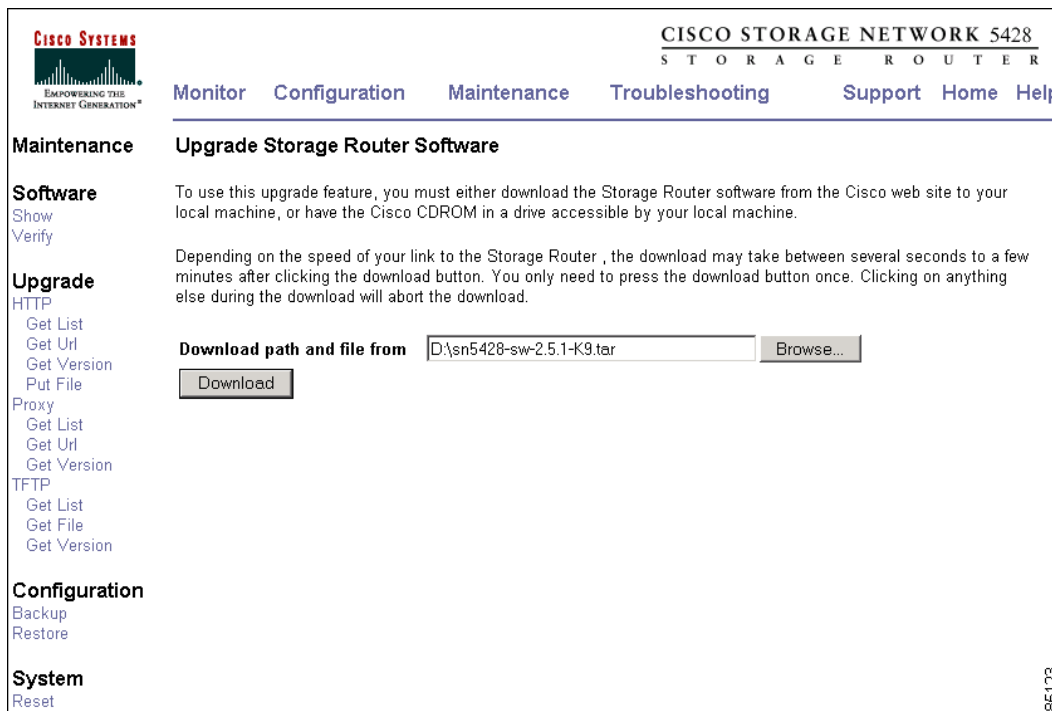
Figure 5 Upgrading via HTTP Put File

- Step 1** Log in as “admin”.
- Step 2** Click **Maintenance** to view information about the software versions currently available to the storage router. If multiple versions of software are available, delete all versions except the currently running version.
- Step 3** Click **HTTP Put File**. The Upgrade Storage Router Software page displays.
- Step 4** Enter the fully qualified path and file name in the **Download path and file from** field, or click **Browse** to navigate to the appropriate file.
- Step 5** Click **Download** to download the software (see [Figure 5](#)).
- Step 6** Click **System Reset**. The Currently Running Version page displays.
- Step 7** Click the **Select next boot version** drop-down arrow and choose 2.5.1-K9 as the next boot version.
- Step 8** (Optional) To save any configuration changes before rebooting, check the **Save unsaved changes** check box.

- Step 9** Click **Reset System** to restart the SN 5428 Storage Router.
- Step 10** After the storage router has rebooted, verify that it is running the new software. (See the [“Determining the SN 5428 Software Version”](#) section on page 6.)

- CSCdy06532
SN 5428 software download fails when using the HTTP Put File function from Microsoft Internet Explorer version 5.5 with service pack 2. The user may receive a “page cannot be displayed error” or the download may appear to hang. This is bug in Microsoft Internet Explorer.

When using the GUI Put File functionality to upgrade SN 5428 software and the upgrade process fails because there is not sufficient space available, the GUI displays an error message indicating the process failed. However, the partially loaded version of software is not removed from the filesystem. If you subsequently attempt to download software via the CLI, the transfer appears to hang.
