Release Notes for Cisco SN 5428 Storage Router Release 3.2.1

These release notes support Cisco SN 5428 Storage Router software release 3.2.1.

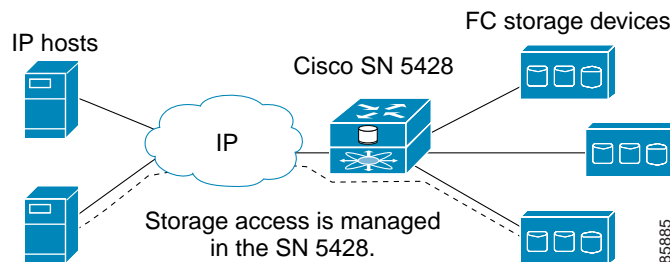
Figure 1 *SCSI Routing*

With SCSI routing, storage device access is managed primarily in the SN 5428. (See [Figure 1](#).)

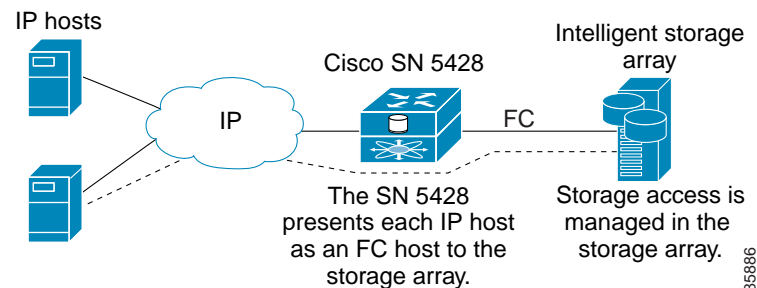
Figure 2 *Transparent SCSI Routing*

Transparent SCSI routing provides IP hosts with transparent access to intelligent storage arrays using iSCSI protocol; that is, each IP host is presented as an FC host to an intelligent storage array. With transparent SCSI routing, availability of storage devices is managed primarily in the intelligent storage array. (See [Figure 2](#).)
