Release Notes for the Catalyst 3750, 3560, 2970, and 2960 Switches, Cisco IOS Release 12.2(44)SE and Later

Revised September 9, 2009

Cisco IOS Release 12.2(44)SE and later runs on all Catalyst 3750, 3560, 2970, and 2960 switches and on Cisco EtherSwitch service modules.

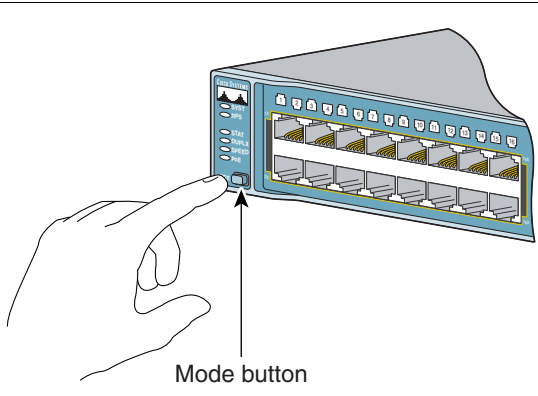
| Step 5 | <p>Press and hold the Mode button for 3 seconds. When all of the LEDs left of the Mode button turn green, release the Mode button.</p> <p>If the LEDs left of the Mode button begin to blink after you press the button, release it. Blinking LEDs mean that the switch has already been configured and cannot go into Express Setup mode. For more information, see the “Resetting the Switch” section.</p> | <p>Mode button</p> |
