Release Notes for Cisco MGX 8950 Software Version 2.1.80

About Release 2.1.80

These release notes describe the system requirements, new features, and limitations that apply to Release 2.1.80 for the MGX 8950 multi-service switch. These notes also contain Cisco support information.

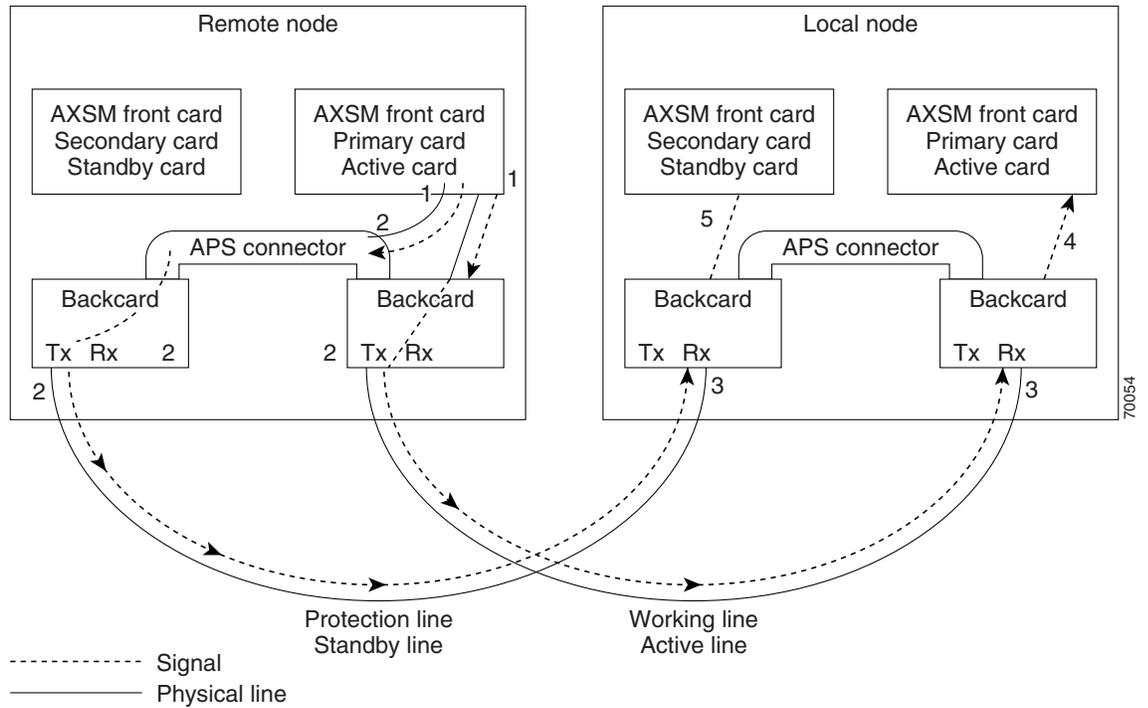
Figure 1 Standard APS Configuration

Figure 1 shows an example of how this process operates in a standard APS configuration, where the primary card monitors the working line and the secondary card monitors the protection line.

1. The signal leaves the front card at the remote end of the line. (See Figure 1 and Figure 2.)
2. The signal passes through the APS connector and both back card transmit ports at the remote end of the line. (See Figure 1 and Figure 2.)
3. The signal travels through both communication lines to the receive ports on both back cards at the local end. (See Figure 1 and Figure 2.)
4. The active front card processes the signal that is received on the active line. (See Figure 1 and Figure 2.)
5. The standby card monitors only the status of the standby line. (See Figure 1 and Figure 2.)
6. If necessary, the signal passes through the APS connector to the front card. (See Figure 2.)

Line failures are always detected at the receive end of the line. This is where a switchover occurs when a failure is detected. Two different types of switchovers can occur, depending on whether the APS was configured as unidirectional or bidirectional in the **cnfapsln** command:

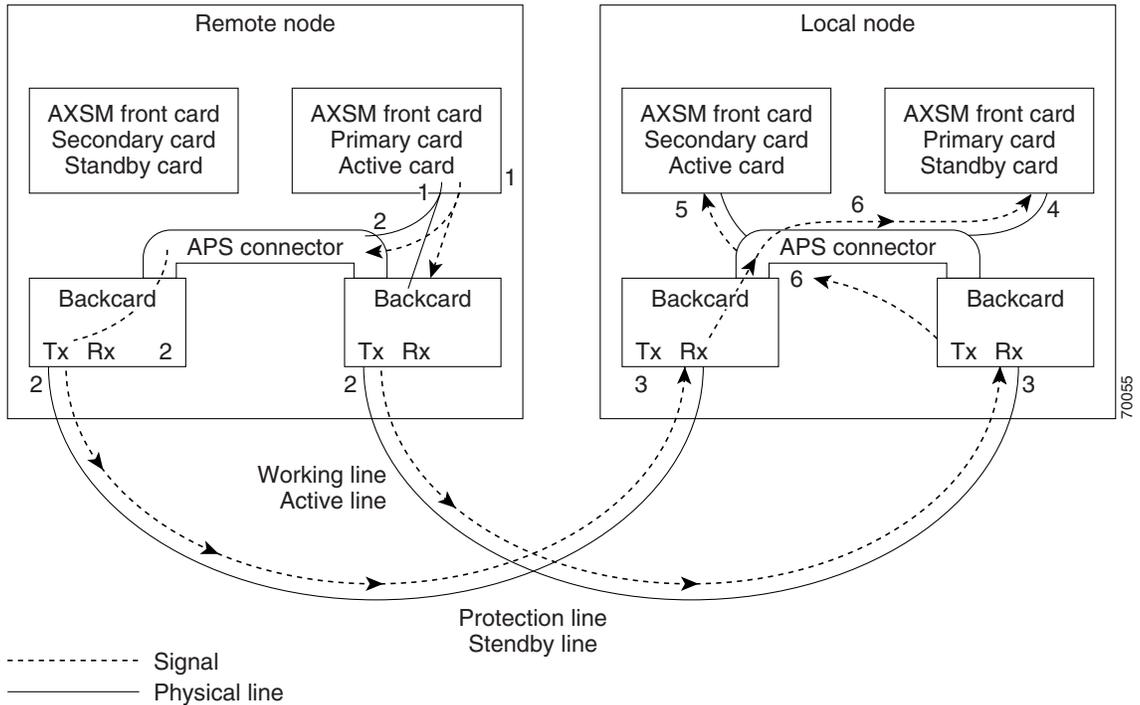
Figure 2 Crossed APS Configuration

Figure 2 shows an example of how the APS communication process operates in a crossed APS configuration, where the secondary card monitors the working line that is attached to the primary card, and the primary card monitors the protection line that is connected to the secondary card.

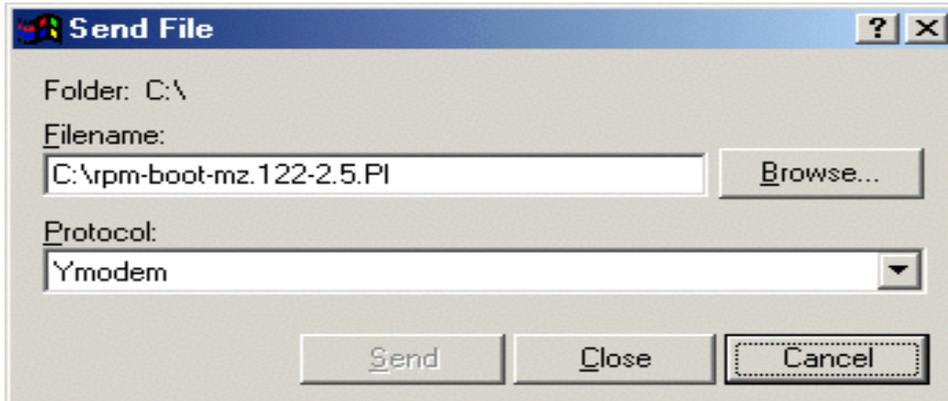
Step 4 Use the Transfer-->Send File option in HyperTerminal to start the image transfer.

In the Filename box, browse and choose the image file to be downloaded. Also since we used the “y” option while invoking the xmodem, set the transfer protocol to ymodem or use Xmodem protocol by not specifying the -y option on the command line.
