# Release Notes for Cisco MGX Route Processor Module (RPM-PR) IOS Release 12.3(7)T3 for MGX Releases 1.3.10 and 5.0.10

These release notes are part OL-6309-01 Rev. A0, August 18, 2004

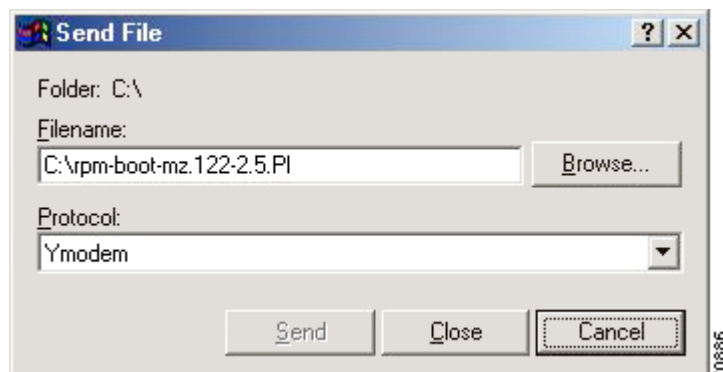
**Step 4** Use the Transfer-->Send File option in HyperTerminal to start the image transfer.

In the Filename box, browse and choose the image file to be downloaded. Also since we used the “y” option while invoking the xmodem, set the transfer protocol to ymodem or use Xmodem protocol by not specifying the –y option on the command line.

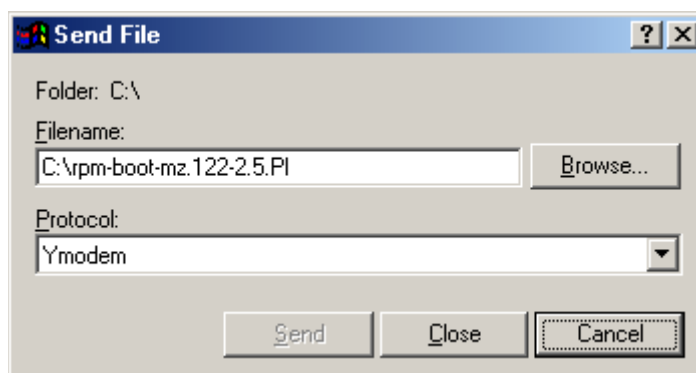
**Step 4** Use the Transfer-->Send File option in HyperTerminal to start the image transfer.

In the Filename box, browse and choose the image file to be downloaded. Also since we used the “y” option while invoking the xmodem, set the transfer protocol to ymodem or use Xmodem protocol by not specifying the -y option on the command line.
