# Release Notes for Cisco MGX Route Processor Module (RPM/B and RPM-PR) IOS Release 12.2(15)T5 for MGX Releases 1.2.21 and 4.0.10

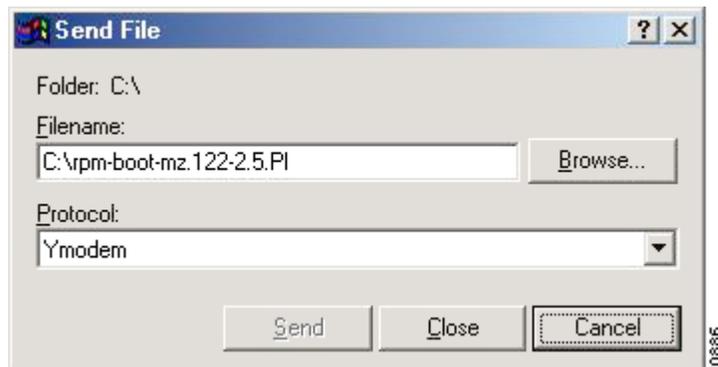
**Step 4** Use the Transfer-->Send File option in HyperTerminal to start the image transfer.

In the Filename box, browse and choose the image file to be downloaded. Also since we used the “y” option while invoking the xmodem, set the transfer protocol to ymodem or use Xmodem protocol by not specifying the -y option on the command line.

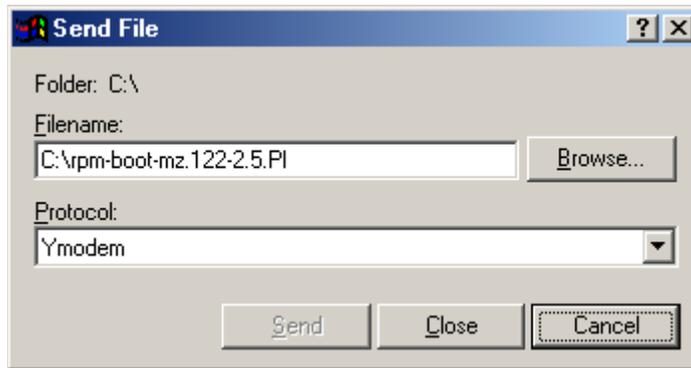
**Step 4** Use the Transfer-->Send File option in HyperTerminal to start the image transfer.

In the Filename box, browse and choose the image file to be downloaded. Also since we used the “y” option while invoking the xmodem, set the transfer protocol to ymodem or use Xmodem protocol by not specifying the -y option on the command line.
