1.1.31 Version Software Release Notes

Cisco WAN MGX 8850, 8230, and 8250 Software

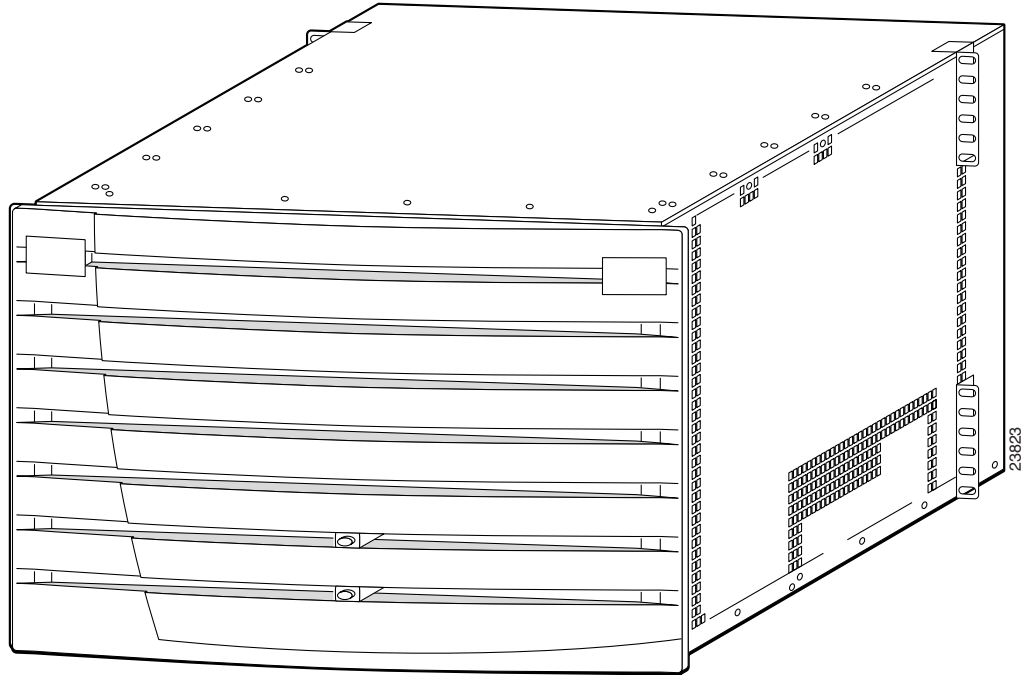
Figure 1 *MGX 8230 with Door Attached*

Figure 1 shows the MGX 8230 with its door attached. Note that there are light pipes in the door that display the status of the processor models (PXMs). Figure 2 is a conceptual drawing of an MGX 8230 showing the dimensions and the slot numbering. The slot numbering is as it appears from the front of the MGX 8230; slots 8 and 9 refer to back card slots only.

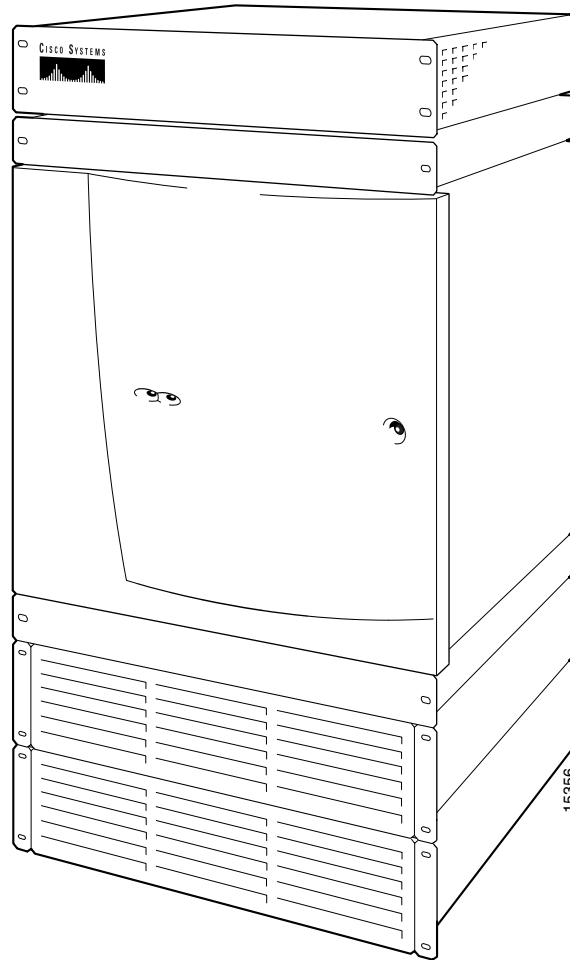
Figure 3 *MGX 8250 Switch*

This chapter contains a brief outline of the features of the Cisco MGX 8250 switch. An illustration of the AC-powered version of the switch appears in Figure 3.

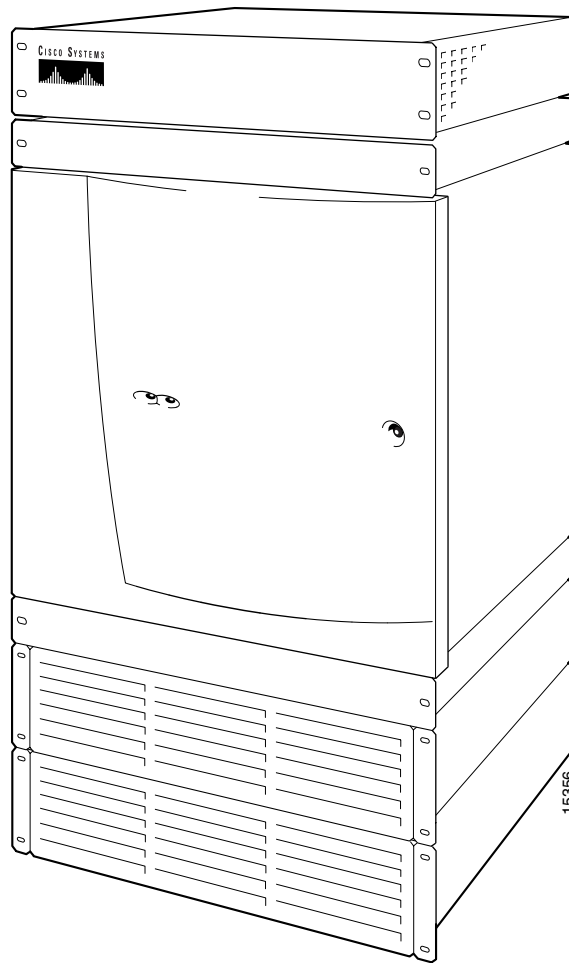
Figure 4 MGX 8850 Switch

An illustration of the AC-powered version of the switch appears in Figure 4.
