Troubleshooting Tools

This chapter provides a description of the available VISM 2.0 troubleshooting tools together with some remedial actions that can be taken under various abnormal situations.

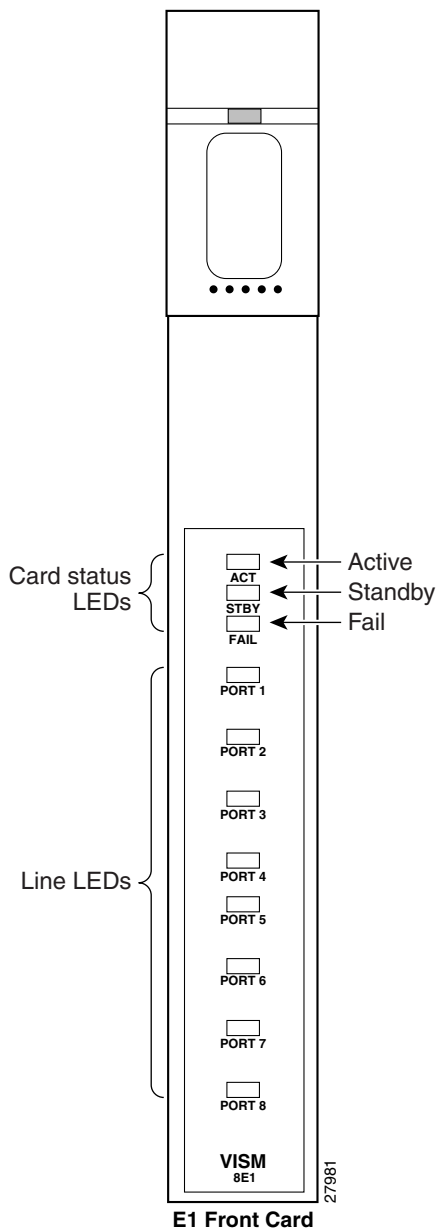
Figure 8-1 ViSM Front Card LEDs

The first level of troubleshooting tools is the set of LED indicators located on the VISM card itself. The VISM card has 3 card status LEDs and 8 line status LEDs, organized as shown in Figure 8-1.

The ACTIVE LED is GREEN, when the card is in the ACTIVE state.

STANDBY LED will be lit Orange, when the card is in the STANDBY or MISMATCH state or when the card's DSPs are getting downloaded as part of card booting up. STANDBY LED is a blinking Orange when the card is in the boot state.

FAIL LED will be lit RED when the card is in the FAIL state or during some stages of the bootup process.

The 8 line LEDs correspond to the eight T1 or E1 ports on the back card and are lit as follows:

GREEN - if the line has been added and there is no alarm on that line.

ORANGE - if the line has been added and there is a YELLOW alarm condition on the line.

RED - if the line has been added and there is a LOS condition (RED alarm condition), LOF or AIS on the line.
