Cisco TelePresence System C/SX/EX/MX/Profile Series

Software release notes TC6

D1501720

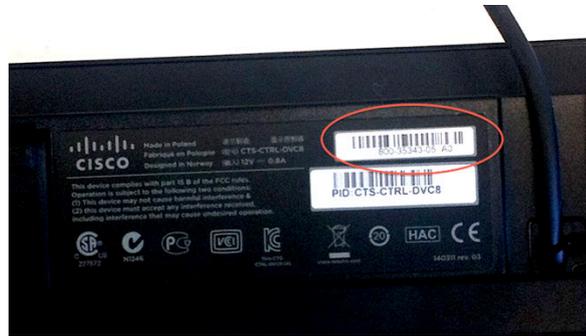
The TAN number can be found on the back of the Cisco TelePresence Touch 8 panel on the sticker positioned in the upper right corner.

Identify the minimum software supported by using the TAN number with this table.

There are as of TC6 four hardware levels of the Touch 8. The new hardware levels 1, 2 and 3 require newer software. From TC5.1.3 there is a lock preventing a downgrade of a system to a software version that is not supported by the connected touch panel.
