# Upgrading Cisco UCS Hardware

## Upgrading Fabric Interconnects

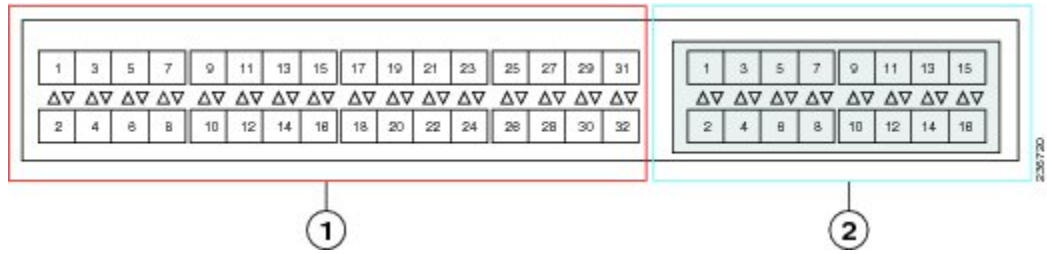
**Figure 1: Cisco UCS 6248 Port Numbering**

1	Slot 1, 32 fixed universal ports	2	Slot 1, 16 expansion universal ports
---	----------------------------------	---	--------------------------------------

Since a UCS 6140 has 40 ports on slot 1 and a UCS 6248 has 32 ports, any ports currently configured on ports 1/33 to 1/40 of the UCS 6140 will have to be moved during the upgrade process.

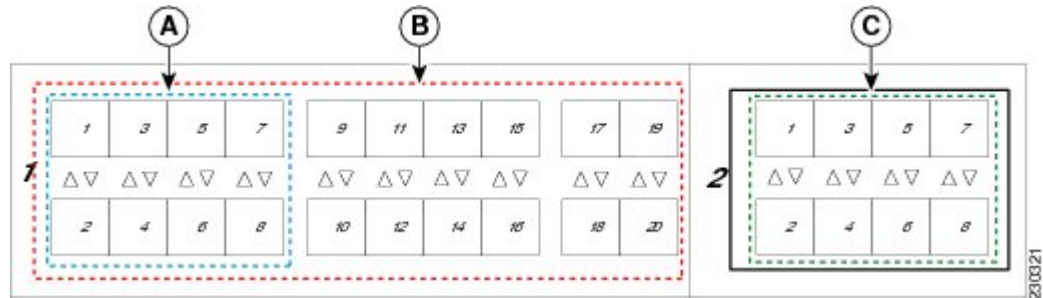
**Figure 2: Cisco UCS 6120 Port Numbering when Configured with the N10-E0080 Expansion Module**

A	Slot 1, ports 1 through 8: 10-Gigabit or 1 Gigabit Ethernet capable ports	C	Slot 2 Fibre Channel ports 1 through 8
B	Slot 1, ports 1 through 20: 10-Gigabit Ethernet ports

be appropriate for all situations as it will mean that all ports in slot two are fibre channel. If you want to reconfigure ports 2/1 to 2/8 to use ports 2/9 to 2/16, do so after the upgrade is completed.

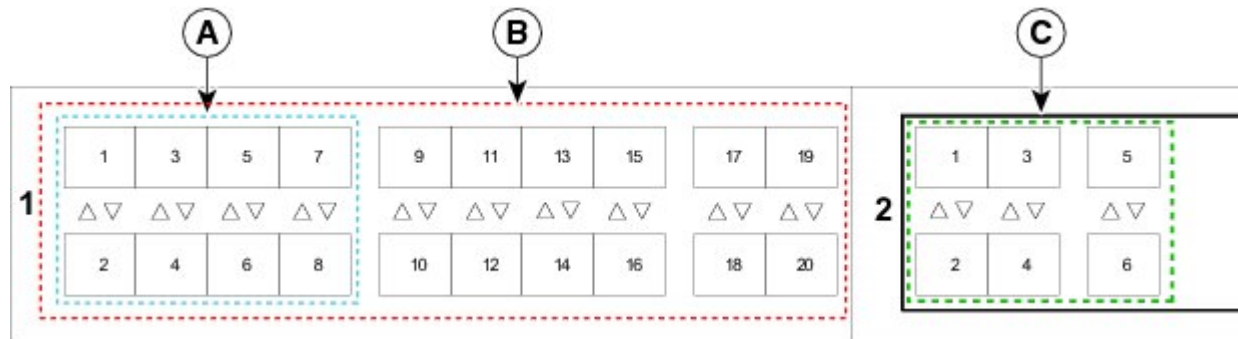
**Figure 3: Cisco UCS 6120 Port Numbering when Configured with the N10-E0060 Expansion Module**

A	Slot 1, ports 1 through 8: 10-Gigabit or 1 Gigabit Ethernet capable ports	C	Slot 2 Fibre Channel ports 1 through 6
B	Slot 1, ports 1 through 20: 10-Gigabit Ethernet ports

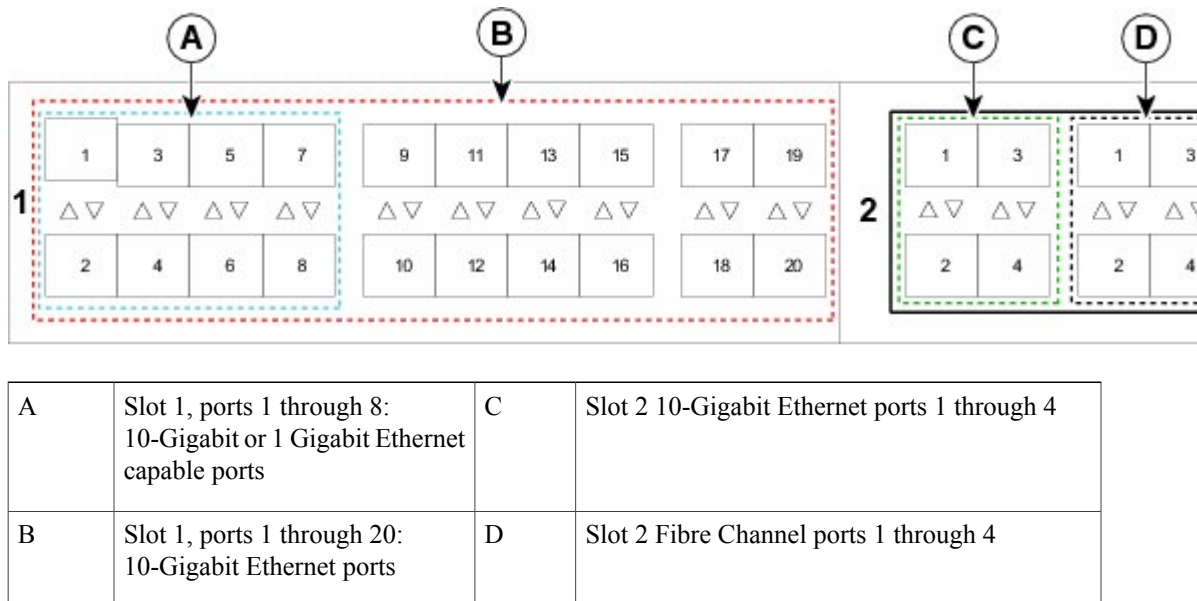
**Figure 5: Cisco UCS 6120 Port Numbering when Configured with the N10-E0440 Expansion Module**

- If you have an N10-E0440 expansion module in your UCS 6120, the simplest direct mapping would be to allow Ethernet ports 2/1 to 2/4 on the UCS 6248 to carry over, then remap the fibre channel ports to new port numbers on either slot 1 or slot 2.
