Upgrading Cisco UCS Hardware

Upgrading Fabric Interconnects

Fabric Interconnect Upgrade Considerations

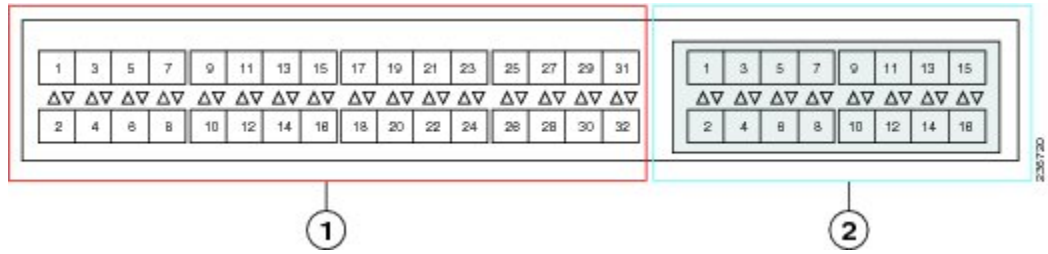
Figure 1: Cisco UCS 6248 Port Numbering

Since a UCS 6140 has 40 ports on slot 1 and a UCS 6248 has 32 ports, any ports currently configured on ports 1/33 to 1/40 of the UCS 6140 will have to be moved during the upgrade process.

1	Slot 1, 32 fixed universal ports	2	Slot 1, 16 expansion universal ports
---	----------------------------------	---	--------------------------------------

On the UCS 6120 fabric interconnect, the fixed ports on slot 1 are all ethernet ports, which might be further configured as Server ports or uplink Ethernet ports. On the UCS 6248 fabric interconnect, you can separate the 32 physical ports in slot one into two contiguous pools, low numbered ports being Ethernet ports and high numbered ports being Fibre Channel ports. When upgrading to a UCS 6248, the UCS 6120 port mappings can be directly carried over on fixed ports with no reconfiguration required. When upgrading a UCS 6140 to a UCS 6296, the port mappings can be directly carried over on fixed ports with no reconfiguration required.

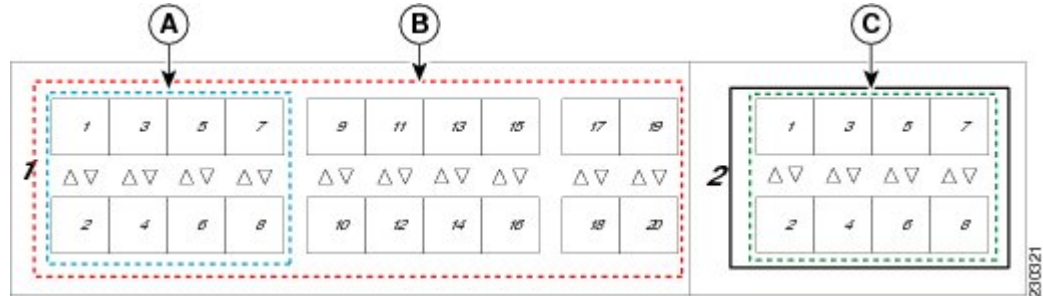
Figure 2: Cisco UCS 6120 Port Numbering when Configured with the N10-E0080 Expansion Module

A	Slot 1, ports 1 through 8: 10-Gigabit or 1 Gigabit Ethernet capable ports	C	Slot 2 Fibre Channel ports 1 through 8
B	Slot 1, ports 1 through 20: 10-Gigabit Ethernet ports

be appropriate for all situations as it will mean that all ports in slot two are fibre channel. If you want to reconfigure ports 2/1 to 2/8 to use ports 2/9 to 2/16, do so after the upgrade is completed.

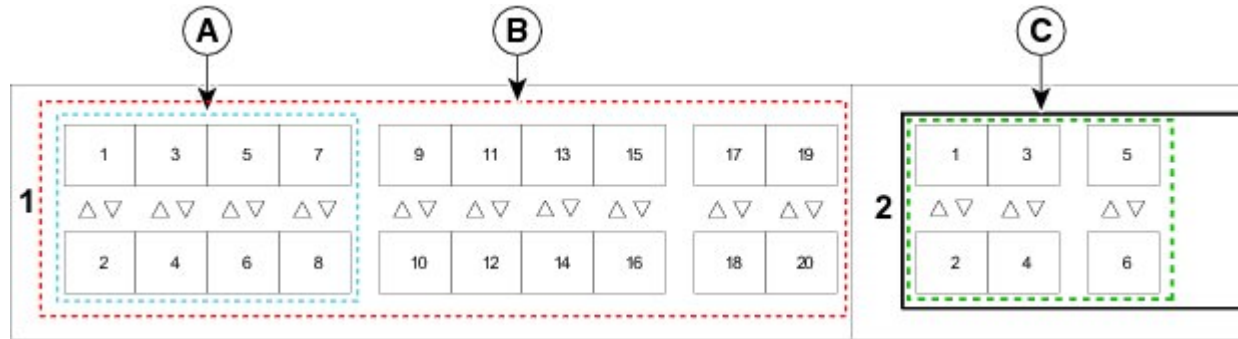
Figure 3: Cisco UCS 6120 Port Numbering when Configured with the N10-E0060 Expansion Module

A	Slot 1, ports 1 through 8: 10-Gigabit or 1 Gigabit Ethernet capable ports	C	Slot 2 Fibre Channel ports 1 through 6
B	Slot 1, ports 1 through 20: 10-Gigabit Ethernet ports

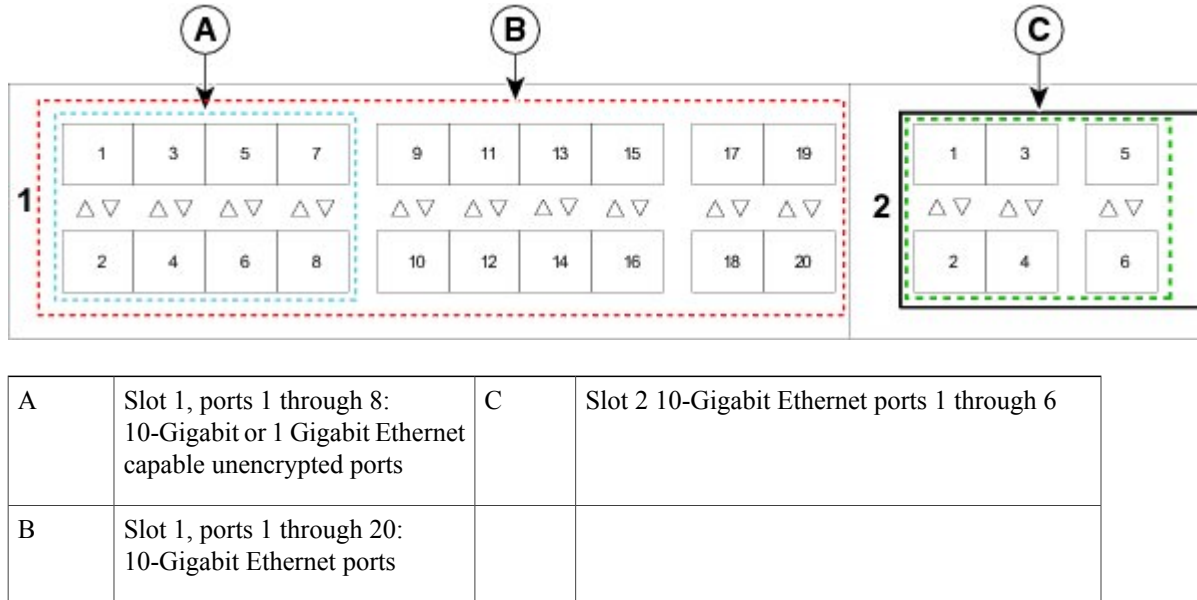
Figure 4: Cisco UCS 6120 Port Numbering when Configured with the N10-E0600 Expansion Module

- If you have an N10-E0600 Fibre channel expansion module in your UCS 6120, the existing Ethernet configurations can simply carry over to the UCS 6248, with ports 2/7 to 2/16 potentially configurable for either Ethernet or FC.

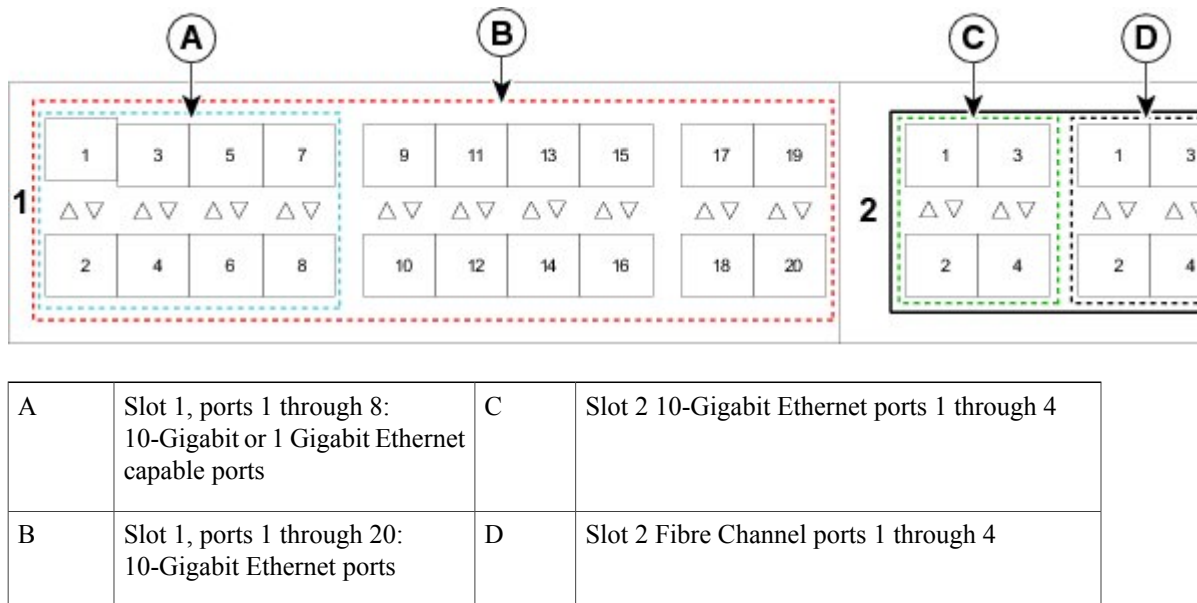
Figure 5: Cisco UCS 6120 Port Numbering when Configured with the N10-E0440 Expansion Module

- If you have an N10-E0440 expansion module in your UCS 6120, the simplest direct mapping would be to allow Ethernet ports 2/1 to 2/4 on the UCS 6248 to carry over, then remap the fibre channel ports to new port numbers on either slot 1 or slot 2.
