# Cisco 3640 Router - PBX Interoperability: Nortel Meridian Option 11 Rel. 24 PBX with Analog FXS and FXO interfaces to an MGCP Gateway

- This note describes interoperability of the Nortel Meridian Option 11 PBX with Cisco Call Manager using Cisco C3640 Analog FXS/FXO interfaces as an MGCP Gateway.

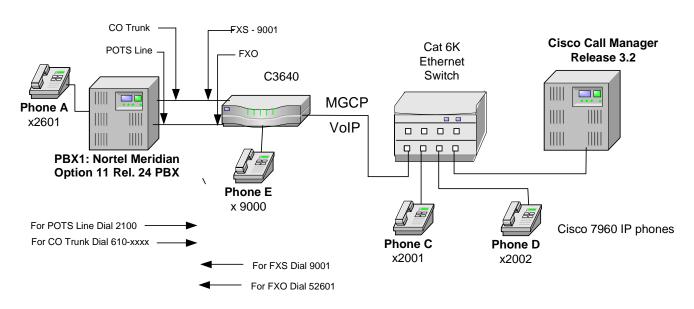
#### **Network Topology**

- The Network Topology diagram shows the test set-up for end-to-end interoperability between the Cisco Call Manager connected to the PBX via Cisco 3640 analog FXS and FXO voice ports linked as an MGCP gateway.

- Connectivity is achieved first by using the analog FXS loop start voice port on the MGCP gateway to a loop start CO Trunk port on the Nortel Meridian Option 11 PBX. Then by using the analog FXO loop start voice port on the MGCP gateway to a loop start phone line (POTS) port on a Nortel Meridian PBX.

## **Basic Call Setup End-to-End Configuration**
