Cisco 3640 Router-PBX Interoperability: Lucent/Avaya Definity G3si V7 PBX with T1 CAS to an MGCP Gateway

Introduction

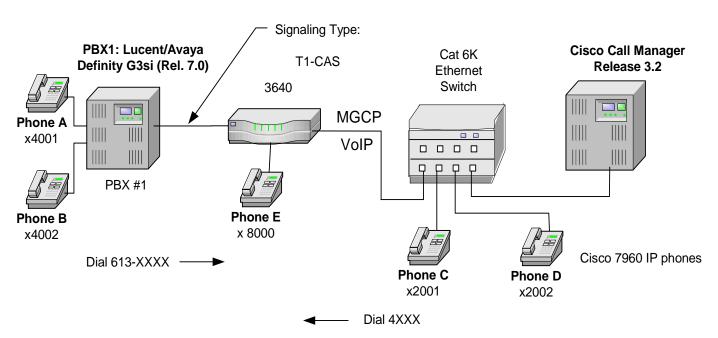
Figure 1. Network Topology or Test Setup

- This note describes interoperability of Lucent/Avaya Definity G3si Version 9 PBX with Cisco CallManager using Cisco 3640 with T1 CAS as an MGCP Gateway.
- The Network Topology diagram shows the test set-up for end-to-end interoperability between the Cisco CallManager connected to the PBX via Cisco 3640 with T1 CAS link as an MGCP Gateway.
- Connectivity is achieved by using the T1-CAS signaling protocol type on the MGCP gateway and the Lucent/Avaya PBX.
- Wink-Start signaling is best choice for reliability.

Basic Call Setup End-to-End Configuration

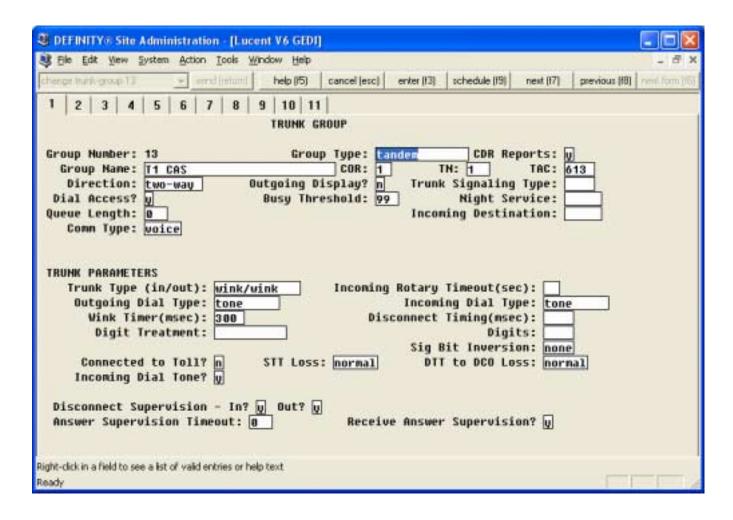
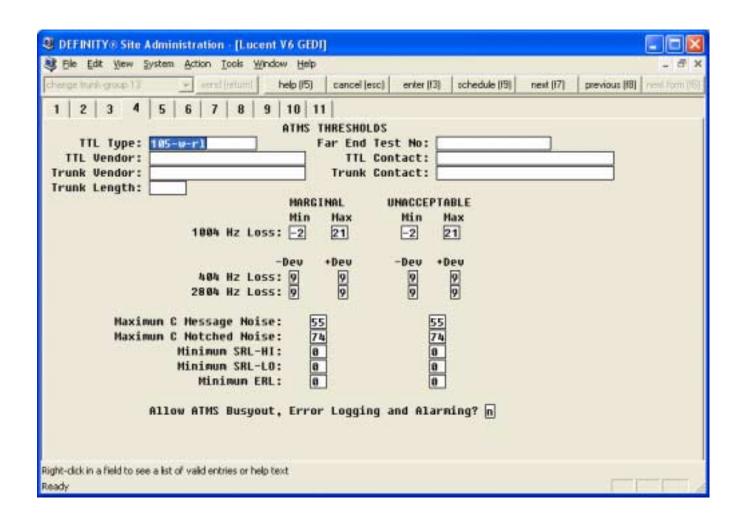
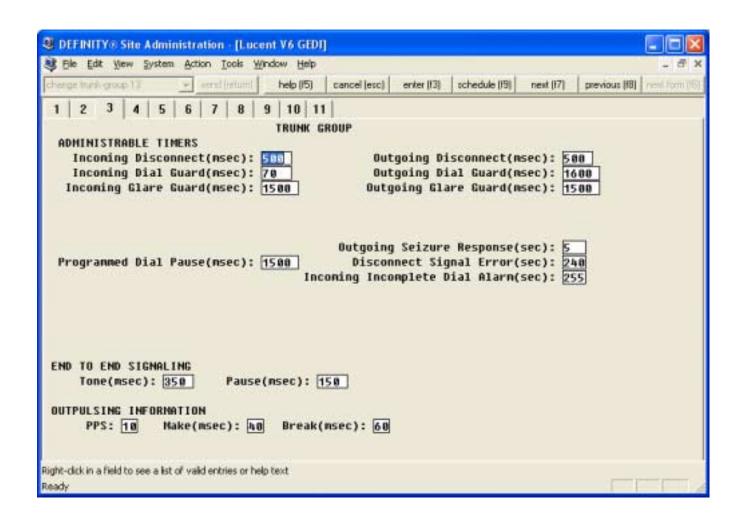
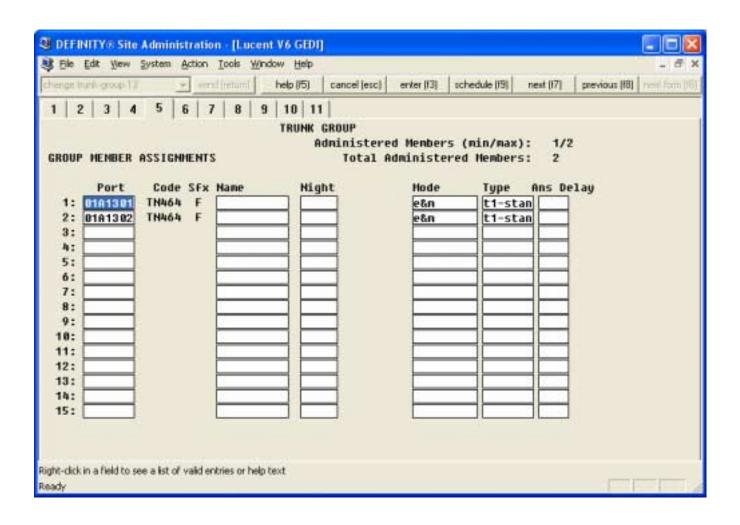
Trunk Group (Wink-Start signaling)

② DEFINITY® Site Administration - [Lucent V6 GEDI]	
Ble Edit Yew System Action Tools Window Help	- 6 X
change hunk-group 13 y annul return help (/5) cancel (esc.) enter (/3) schedule (/9) next (/7) previous (/8) n	ent from (fo)
1 2 3 4 5 6 7 8 9 10 11 TRUNK FEATURES	
ACA Assignment? Measured: none Maintenance Tests? Maintenance Tests	
Incoming Tone (DTMF) ANI: no Per Call CPN Blocking Code: Per Call CPN Unblocking Code:	
Right-click in a field to see a list of valid entries or help text Ready

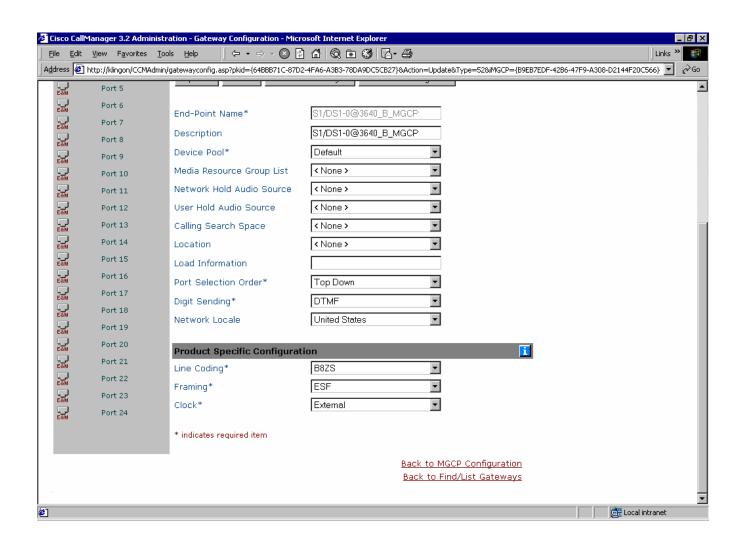
Digital Access T1-CAS Configuration Cisco CallManager 3.2 Administration - Gateway Configuration - Microsoft Internet Explorer _ B × Links » <u>File Edit View Favorites Tools Help</u> Address bttp://klingon/CCMAdmin/gatewayconfig.asp?pkid={64BB871C-87D2-4FA6-A3B3-78DA9DC5CB27}&Action=Update&Type=52&MGCP={B9EB7EDF-42B6-47F9-A308-D2144F20C566} System Route Plan Service Feature Device User Application Help CISCO SYSTEMS Cisco CallManager Administration For Cisco IP Telephony Solutions **Gateway Configuration** Back to MGCP Configuration Back to Find/List Gateways Product : Cisco 364X <<u>Add a New Port</u>> Gateway: \$1/D\$1-0@3640_B_MGCP Device Protocol: Digital Access T1 E&M Port 1 Registration: Not Registered E&M Port 2 IP Address: 10.1.1.73 E&M Port 3 Status: Ready Port 4 Update Delete Reset Gateway Cancel Changes Port 5 Port 6 End-Point Name* S1/DS1-0@3640_B_MGCP Port 7 Description S1/DS1-0@3640_B_MGCP Port 8 Default • Device Pool* Port 9 • Media Resource Group List < None > E&M Port 10 • Network Hold Audio Source < None > Port 11 ▼ User Hold Audio Source < None > Port 12 Port 13 • Calling Search Space < None > E&M • < None > Location E&M Port 15 Load Information E&M Port 16 Top Down Port Selection Order* • Port 17 Бтис Done
