Release Notes for Cisco Aironet Access Points and Bridges for Cisco IOS Release 12.4(10b)JA4

These release notes describe caveats and features for maintenance release Cisco IOS Release 12.4(10b)JA4. This release supports 32-Mb Cisco autonomous access points, including Cisco Aironet 1130, 1240, and 1250 series access points, 1300 series access point/bridges, and 1400 series bridges.

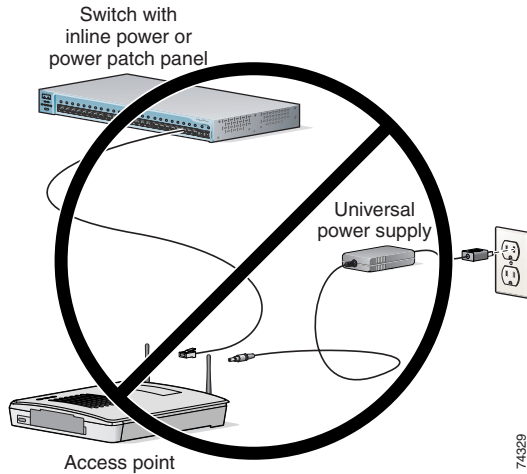
Figure 2 *Improper Power Configuration Using Two Power Sources*

You cannot provide redundant power to 1130 series access points with both DC power to its power port and inline power from a patch panel or powered switch to the access point Ethernet port. If you apply power to the access point from both sources, the switch or power patch panel might shut down the port to which the access point is connected. [Figure 2](#) shows the power configuration that can shut down the port on the patch panel or powered switch.
