Release Notes for Cisco Aironet 350, 1100, and 1200 Series Access Points for Cisco IOS Release 12.2(15)JA

April 15, 2004

These release notes describe features, enhancements, and caveats for Cisco IOS Release 12.2(15)JA. They also provide important information about Cisco Aironet 350, 1100, and 1200 series access points.

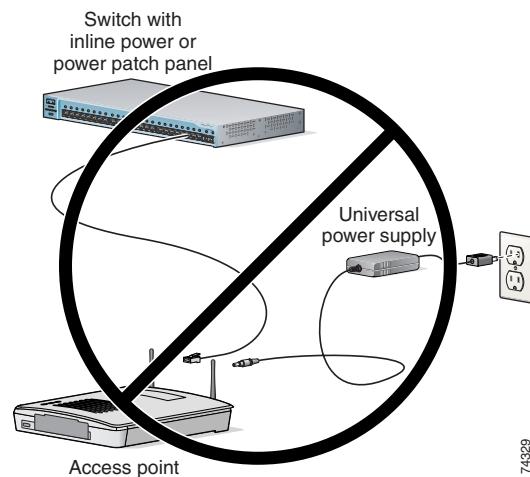
Figure 1 *Improper Power Configuration Using Two Power Sources*

You cannot provide redundant power to 1100 and 1200 series access points with both DC power to its power port and inline power from a patch panel or powered switch to the access point's Ethernet port. If you apply power to the access point from both sources, the switch or power patch panel might shut down the port to which the access point is connected. [Figure 1](#) shows the power configuration that can shut down the port on the patch panel or powered switch.
