Release Notes for Cisco Aironet 350, 1100, and 1200 Series Access Points for Cisco IOS Release 12.2(15)JA

April 15, 2004

These release notes describe features, enhancements, and caveats for Cisco IOS Release 12.2(15)JA. They also provide important information about Cisco Aironet 350, 1100, and 1200 series access points.

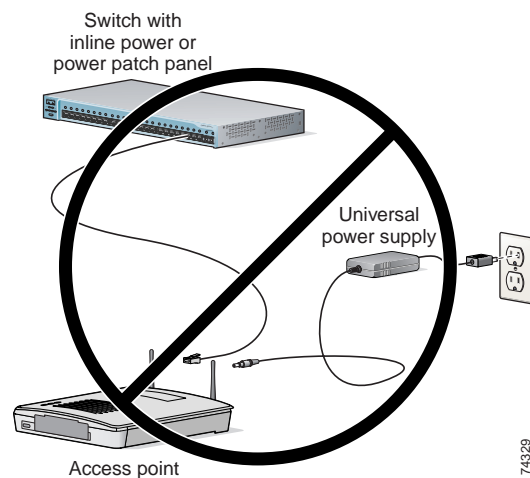
Figure 1 Improper Power Configuration Using Two Power Sources

You cannot provide redundant power to 1100 and 1200 series access points with both DC power to its power port and inline power from a patch panel or powered switch to the access point's Ethernet port. If you apply power to the access point from both sources, the switch or power patch panel might shut down the port to which the access point is connected. [Figure 1](#) shows the power configuration that can shut down the port on the patch panel or powered switch.
