Release Notes for Cisco Aironet 350, 1100, 1130AG, 1200, and 1230AG Series Access Points for Cisco IOS Release 12.3(2)JA

These release notes describe features, enhancements, and caveats for Cisco IOS Release 12.3(2)JA. They also provide important information about Cisco Aironet 350, 1100, 1130AG, 1200, and 1230AG series access points.

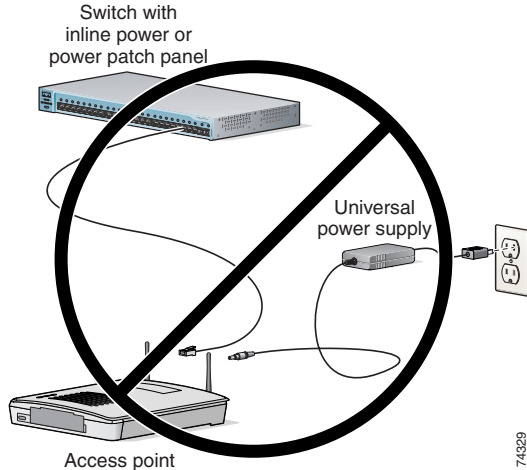
You cannot provide redundant power to 1100, 1130, and 1200 series access points with both DC power to its power port and inline power from a patch panel or powered switch to the access point's Ethernet port. If you apply power to the access point from both sources, the switch or power patch panel might shut down the port to which the access point is connected. [Figure 2](#) shows the power configuration that can shut down the port on the patch panel or powered switch.

Figure 2 *Improper Power Configuration Using Two Power Sources*
