Release Notes for Cisco Aironet 350, 1100, 1130AG, 1200, and 1230AG Series Access Points for Cisco IOS Release 12.3(2)JA

These release notes describe features, enhancements, and caveats for Cisco IOS Release 12.3(2)JA. They also provide important information about Cisco Aironet 350, 1100, 1130AG, 1200, and 1230AG series access points.

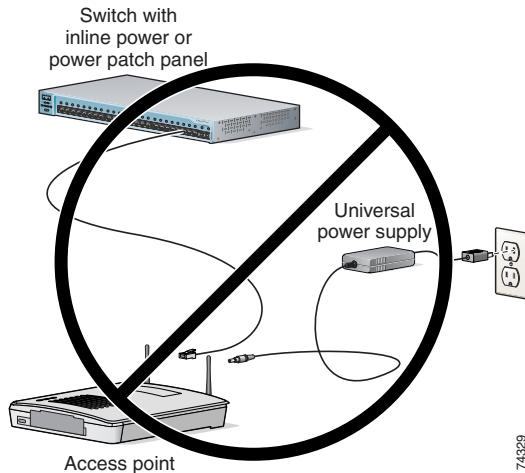
Figure 2 *Improper Power Configuration Using Two Power Sources*

You cannot provide redundant power to 1100, 1130, and 1200 series access points with both DC power to its power port and inline power from a patch panel or powered switch to the access point's Ethernet port. If you apply power to the access point from both sources, the switch or power patch panel might shut down the port to which the access point is connected. [Figure 2](#) shows the power configuration that can shut down the port on the patch panel or powered switch.
