# Release Notes for Cisco Wireless LAN Controllers and Mesh Access Points for Release 4.1.190.5

These release notes describe features, enhancements, and caveats in Release 4.1.190.5 and IOS version AP 12.4(3g)JMA1.

Release 4.1.190.5 is supported on the following Cisco Wireless LAN controller platforms: 2100 series, 4400 series and Wireless Service Module (WiSM) for the Catalyst 6500; and is compatible with the Cisco Wireless Control System (WCS), Release 4.1 and greater.

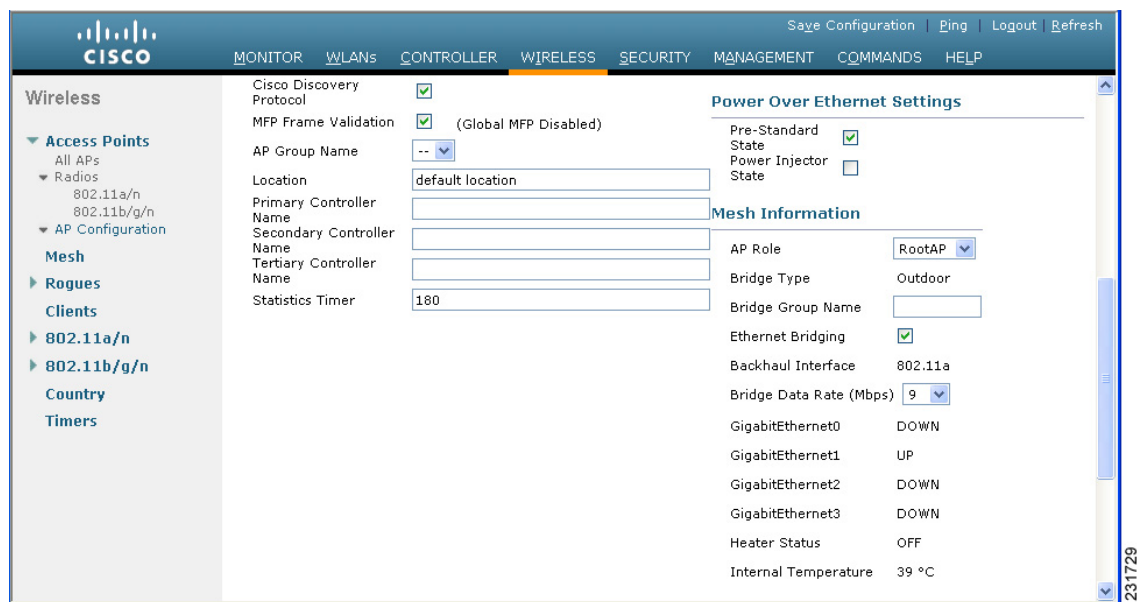
**Figure 1** Wireless > AP1520 > Details

- The **Wireless > AP Name > Details** window displays the state of the four Gigabit Ethernet ports in the Mesh Information section.

The AP1520 supports four Ethernet interfaces: g0–PoE in, g1–PoE out, g2–Cable and g3–Fiber. Both the controller CLI and GUI show the state for each of the four Gigabit Ethernet ports as noted below.

- For the four AP 1520 Ethernet ports, the *Down* state is noted as *Dn*.
- The Up or Down (Dn) status of the four Ethernet ports is reported in the following format: port0:port1:port2:port3. For example, *UpDnDnDn* indicates that port0 is Up and ports 1, 2, and 3 are Down (Dn).
- The AP1510 only reports for one Ethernet port and the Down state is reported as *Down*.
