# Release Notes for Cisco Wireless LAN Controllers and Mesh Access Points for Release 4.2.176.51M

Last Revised: July 1, 2009

These release notes describe features, enhancements, and caveats in release 4.2.176.51M.

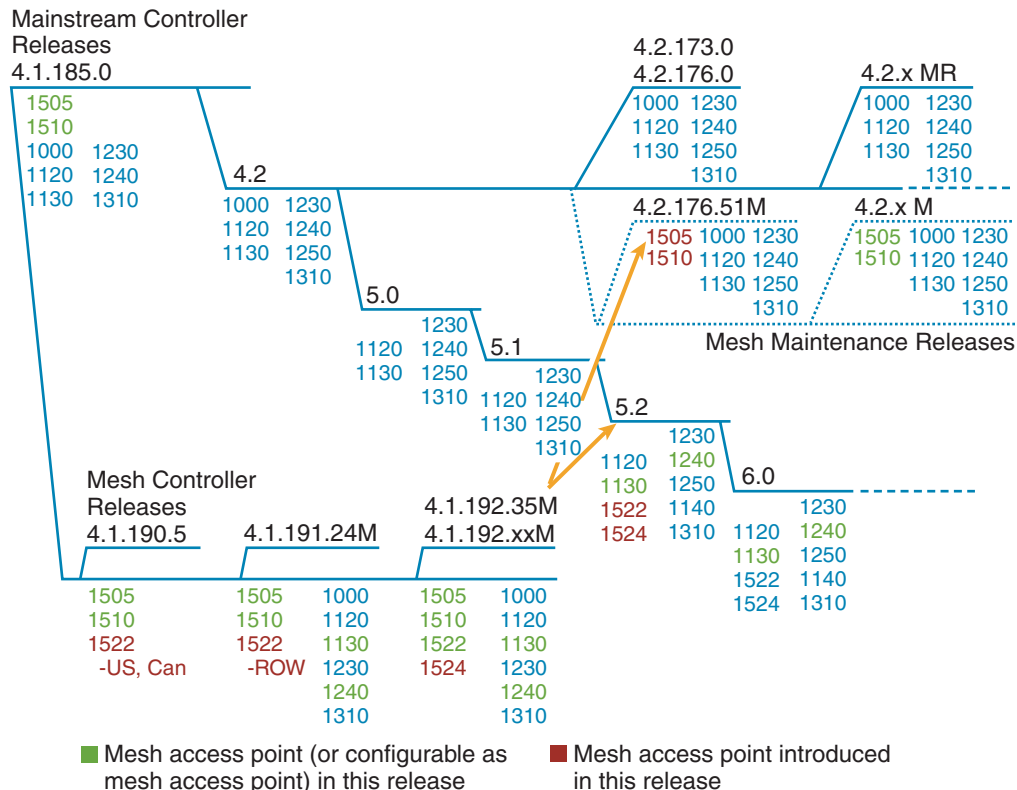
**Figure 1** Controller Mainstream and Mesh Releases

Release 4.2.176.51M provides support for Cisco 1500 (1505 and 1510) series outdoor mesh access points on the controller mainline release base (see Figure 1). The 1505 and 1510 **will not** be supported on any controller release beyond 4.2.
