Release Notes for Cisco Wireless LAN Controllers and Mesh Access Points for Release 4.2.176.51M

These release notes describe features, enhancements, and caveats in release 4.2.176.51M.

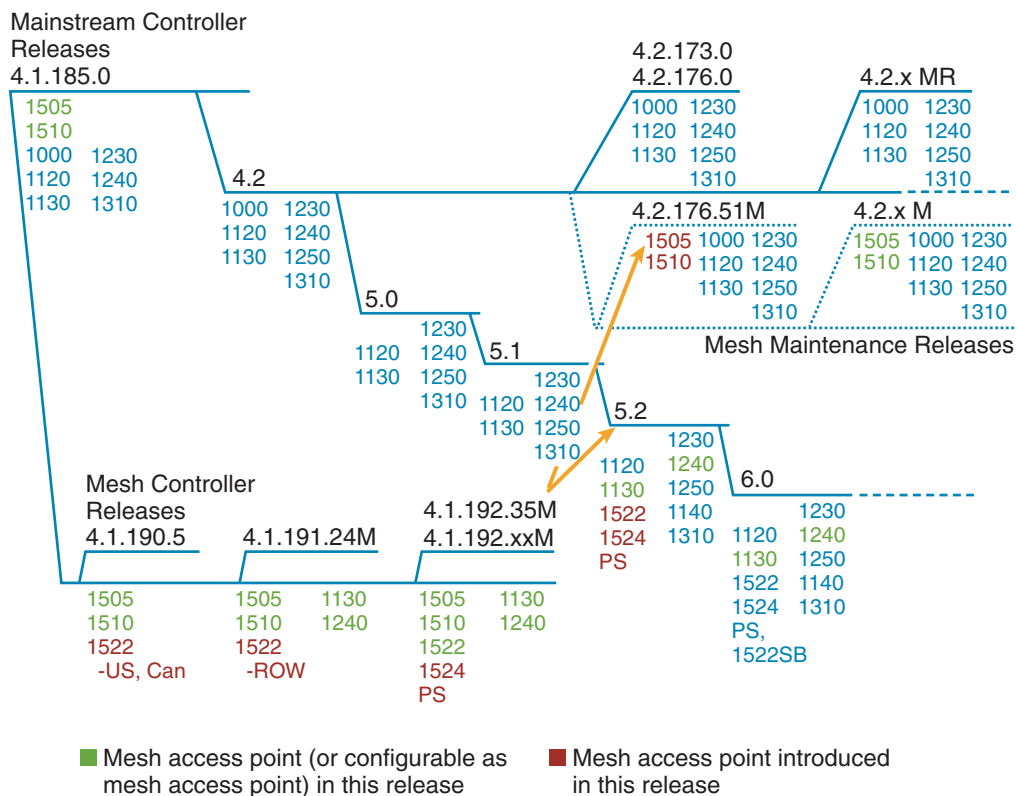
Figure 1 Controller Mainstream and Mesh Releases

Release 4.2.176.51M provides support for Cisco 1500 (1505 and 1510) series outdoor mesh access points on the controller mainline release base (see Figure 1). The 1505 and 1510 **will not** be supported on any controller release beyond 4.2.

Release 4.2.176.51M provides wireless mesh features that are not found in other mainline 4.2.x controller releases. Mesh features are also found for the 1520 series in the main controller release 5.2 and later.
