Troubleshooting uBR Cable Modems Not Coming Online

Document ID: 16510

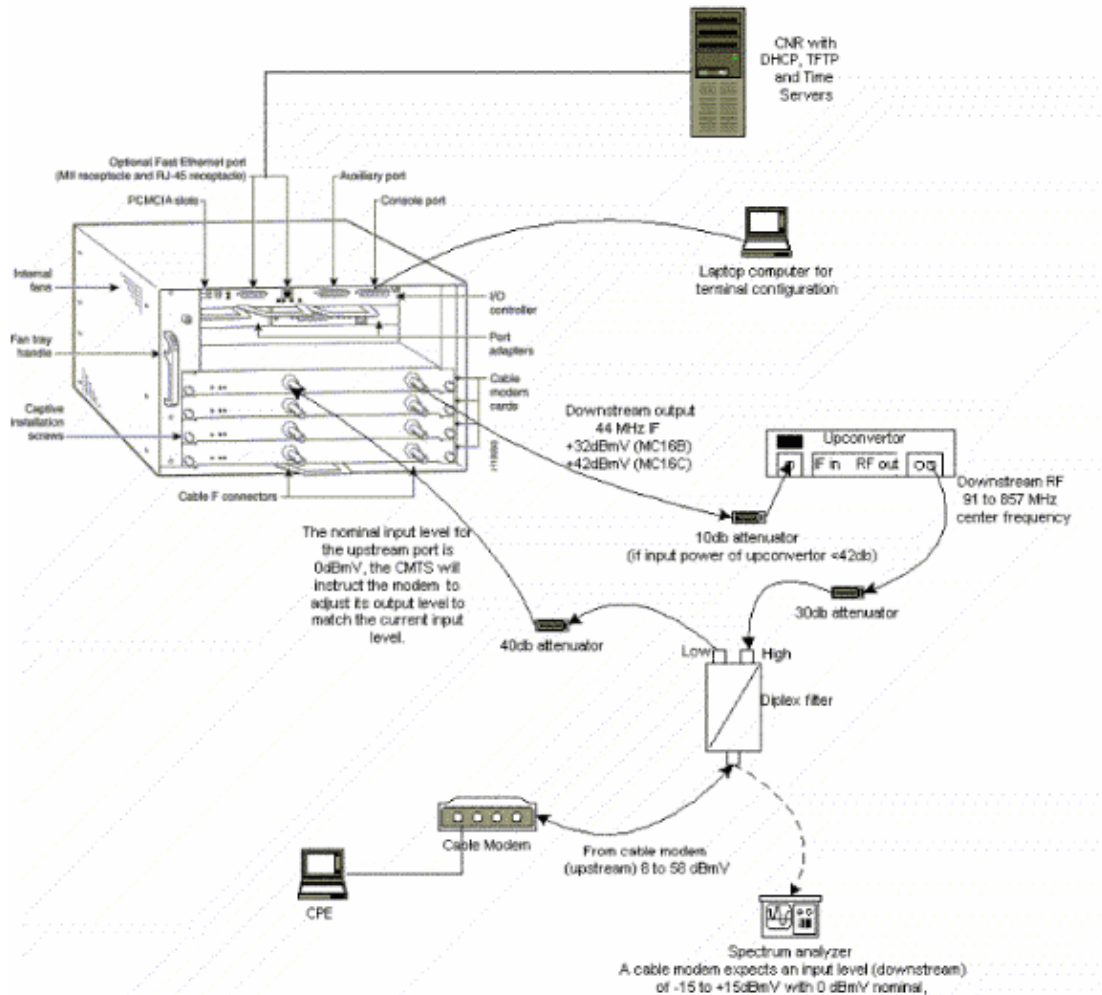
Note: Before starting to troubleshoot any state it is important to look at the state of all the Cable Modems to see whether or not this state applies to all the modems or just a few, and whether this is a new or existing network. If it is an existing network, then investigate any recent changes. In most parts of this document it is assumed that the problem affects all Cable Modems and the following lab topology is applicable:

The above setup can be used for troubleshooting purposes, and rules out RF issues, since this setup excludes Cable TV signals.

Note: The uBR7100 has an integrated upconverter so an external upconverter is not required. Refer to Setting the Integrated Upconverter for more information.

If a modem cannot proceed out of ranging state, the likely cause is an insufficient transmit power level. In the setup above transmit power can be adjusted by adjusting attenuation at the low frequency port. Increased attenuation will result in increased transmit power levels. Roughly 20 – 30 dB of attenuation is a good place to start. After initial ranging init(r1) the modem proceeds onto init(r2) which is where the modem must configure the transmit timing offset and power level to ensure that transmissions from the modem are received at the correct time and are at an acceptable input power level at the CMTS receiver. This is performed through a conversation of unicast RNG–REQ and RNG–RSP messages. The RNG–RSP messages contain power and timing offset corrections the modem must make. The modem continues to transmit RNG–REQ and perform adjustments per RNG–RSP until the RNG–RSP message indicates ranging success or ranging complete by reaching the init(rc) state. If a modem cannot proceed out of init (r2) the transmit power needs to be refined. Below is an output display of a CM in init(r2) state.
