Troubleshooting Unrecognized Voice Interface Cards on Cisco 1750, 1751, and 1760 Routers

Document ID: 5711

This document explains how to troubleshoot a Cisco 1750, Cisco 1751, or Cisco 1760 router that does not recognize Voice Interface Cards (VICs).

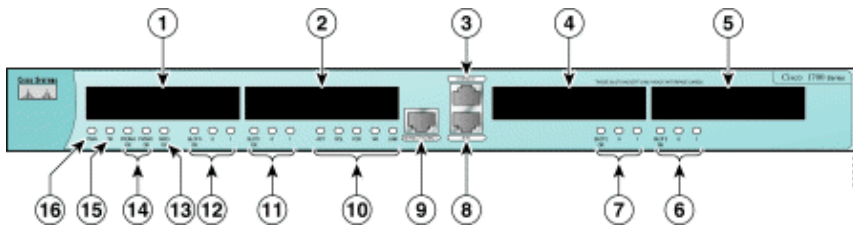
The Cisco 1760 has two PVDM OK LEDs, 0 and 1. There is one for each PVDM card slot. These LEDs are on the front panel. The number 14 indicates them in this diagram:

This table describes the other numbers in this diagram:

Location	Function
1	WIC/VIC Slot 0
2	WIC/VIC Slot 1
3	Console Port
4	VIC Slot 2
5	VIC Slot 3
6	Slot 3 LEDs
7	Slot 2 LEDs
8	Auxiliary Port
9	Ethernet Port
10	Ethernet LEDs
11	Slot 1 LEDs
12	Slot 0 LEDs
13	MOD OK LED
14	PVDM 0/1 OK LEDs
15	Router OK LED
16	Power LED
