# Why Don't RIPv1 and IGRP Support Variable–Length Subnet Mask?

Document ID: 13722

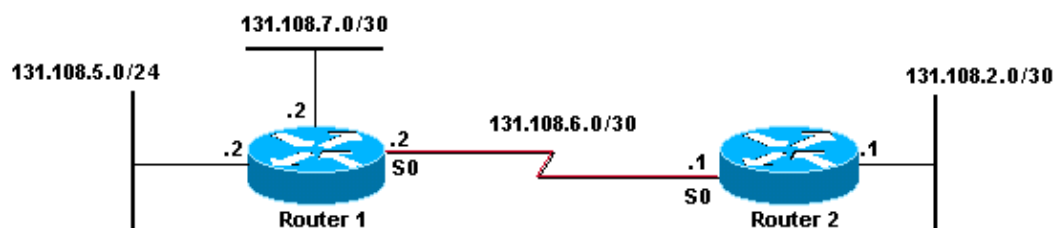
Let's look at an example. In the figure below, Router 1 has three subnets with two different masks (/24 and /30).

- First Router 1 checks to see whether 131.108.5.0/24 is part of the same major net as 131.108.6.0/30, which is the network assigned to the interface that will be sourcing the update.
- It is, and now Router 1 checks whether 131.108.5.0 has the same subnet mask as 131.108.6.0/30.
- Since it doesn't, Router 1 drops the network, and doesn't advertise the route.
- Router 1 now checks whether 131.108.7.0/30 is part of the same major net as 131.108.6.0/30, which is the network assigned to the interface that will be sourcing the update.
- It is, and now Router 1 checks whether 131.108.7.0/30 has the same subnet mask as 131.108.6.0/30.
- Since it does, Router 1 advertises the network.

The above checks determined that Router 1 only includes 131.108.7.0 in its update that is sent to Router 2. Using the **debug ip rip** command, we can actually see the update sent by Router 1. It looks like this:

Notice that in the output above only one subnet is included in the update. This results in the following entry in Router 2's routing table, displayed using the **show ip route** command.
