# Phone Firmware Migration

Automated procedure for mass deployment

Multiplatform Phones team

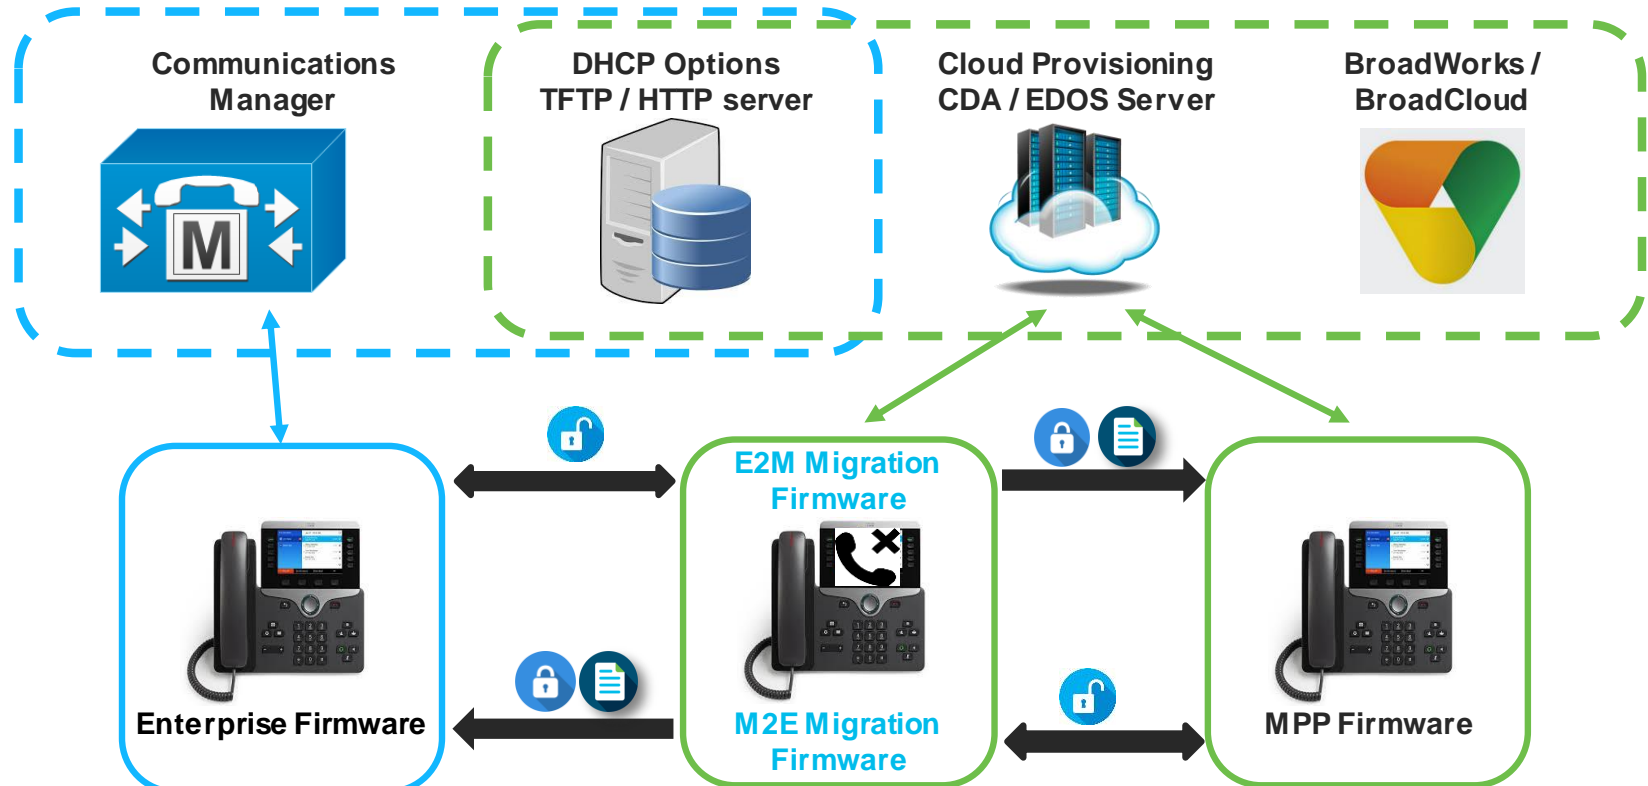
# Firmware Migration Process

## Legend:

- E2M: Enterprise to MPP
- M2E: MPP to Enterprise

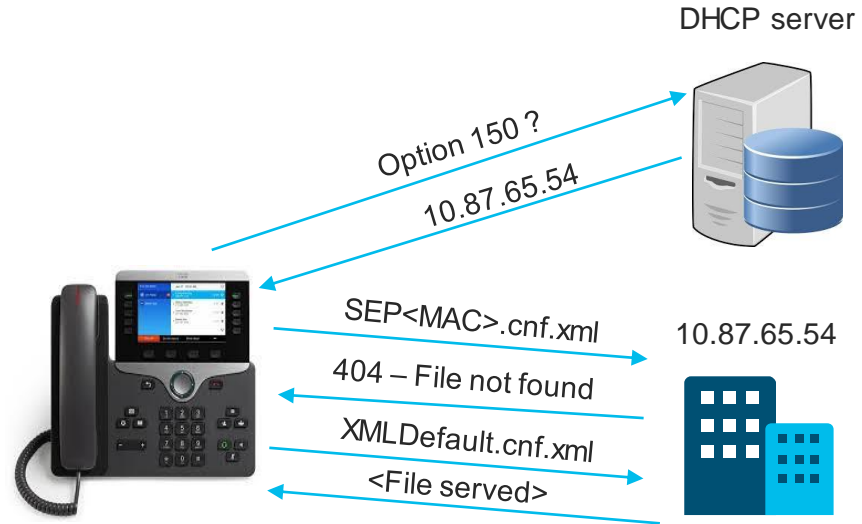
# Enterprise Firmware – DHCP options

- DHCP options – 150, 66
- Order of requests:
  1. SEP<MAC>.cnf.xml
    - Individual phone configuration
  2. XMLDefault.cnf.xml
    - Common configuration
    - Firmware specified per phone model type

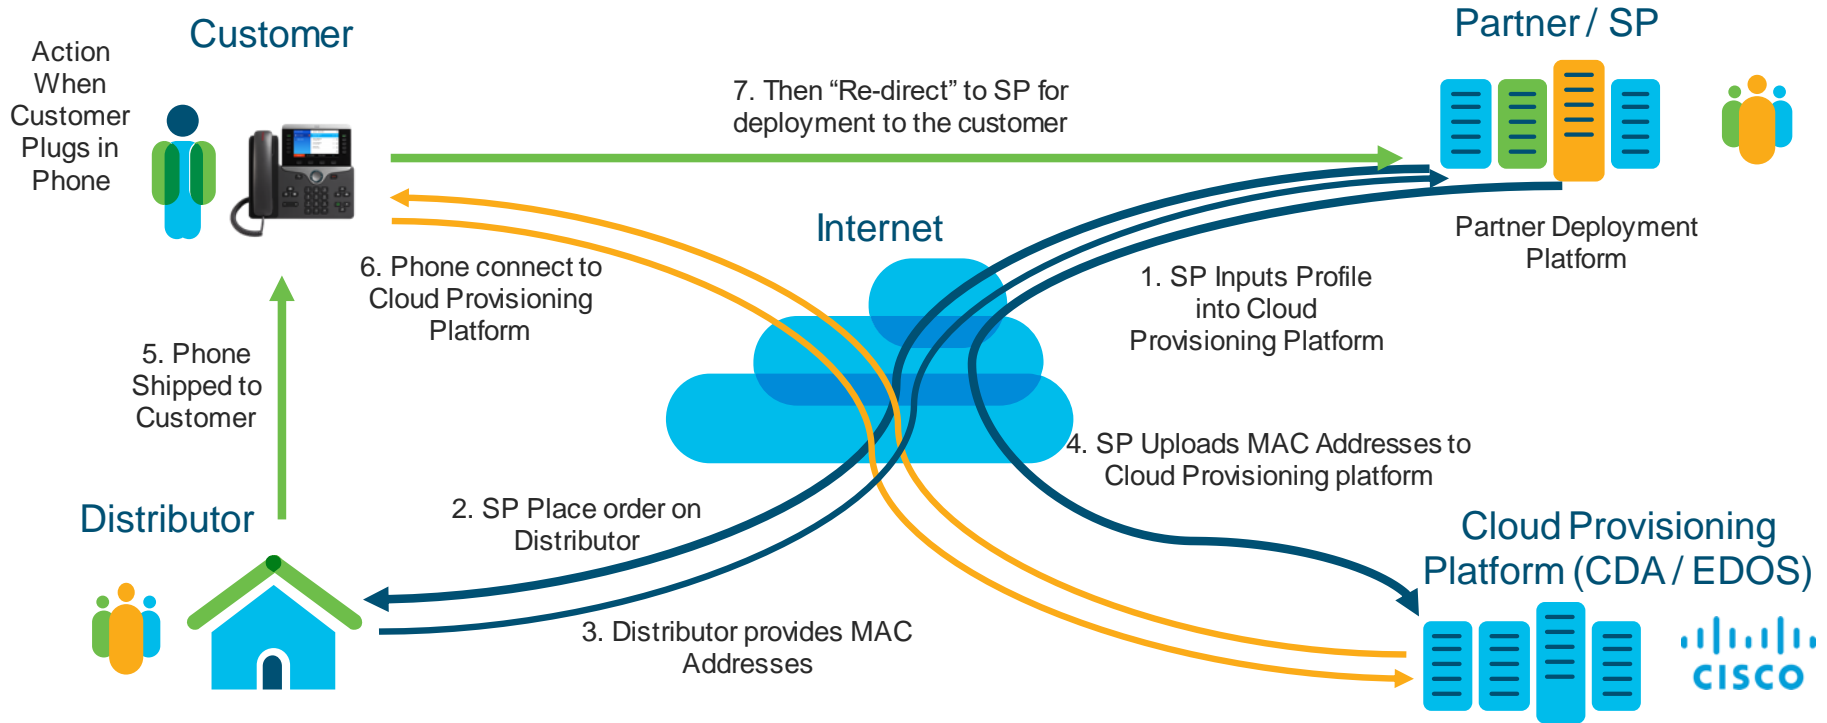
# Process Flow

# MPP firmware – Cloud Provisioning (CDA / EDOS)
