Cisco Firmware Upgrade Guide for 4G LTE and 5G Cellular Modems

This guide provides information about upgrading 4G LTE and 5G cellular modem firmware on Cisco routers, modules, and cellular gateways.

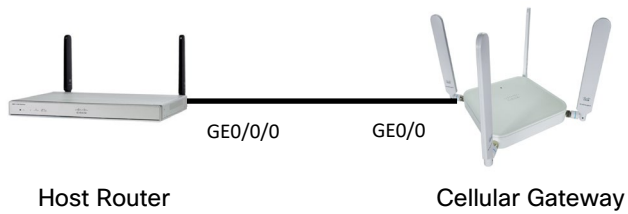
Topology:

Note: To update all 3 versions (based firmware, carrier PRI, and OEM PRI), only 1 firmware upgrade process is needed.

Note: The following examples are used with 17.11.1a version on CG418-E cellular gateway.

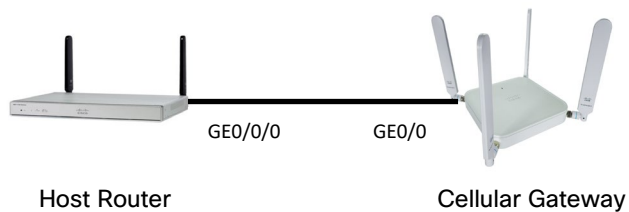
Topology:

- 1st time with .CWE (based firmware file) and .NVU (carrier PRI file) in 1 folder.
- 2nd time with .NVU (OEM PRI file) in 1 folder.
