Cisco Gigabit Ethernet Switch Module for the HP p-Class BladeSystem

Release Notes, Cisco IOS Release 12.2(25)SE2

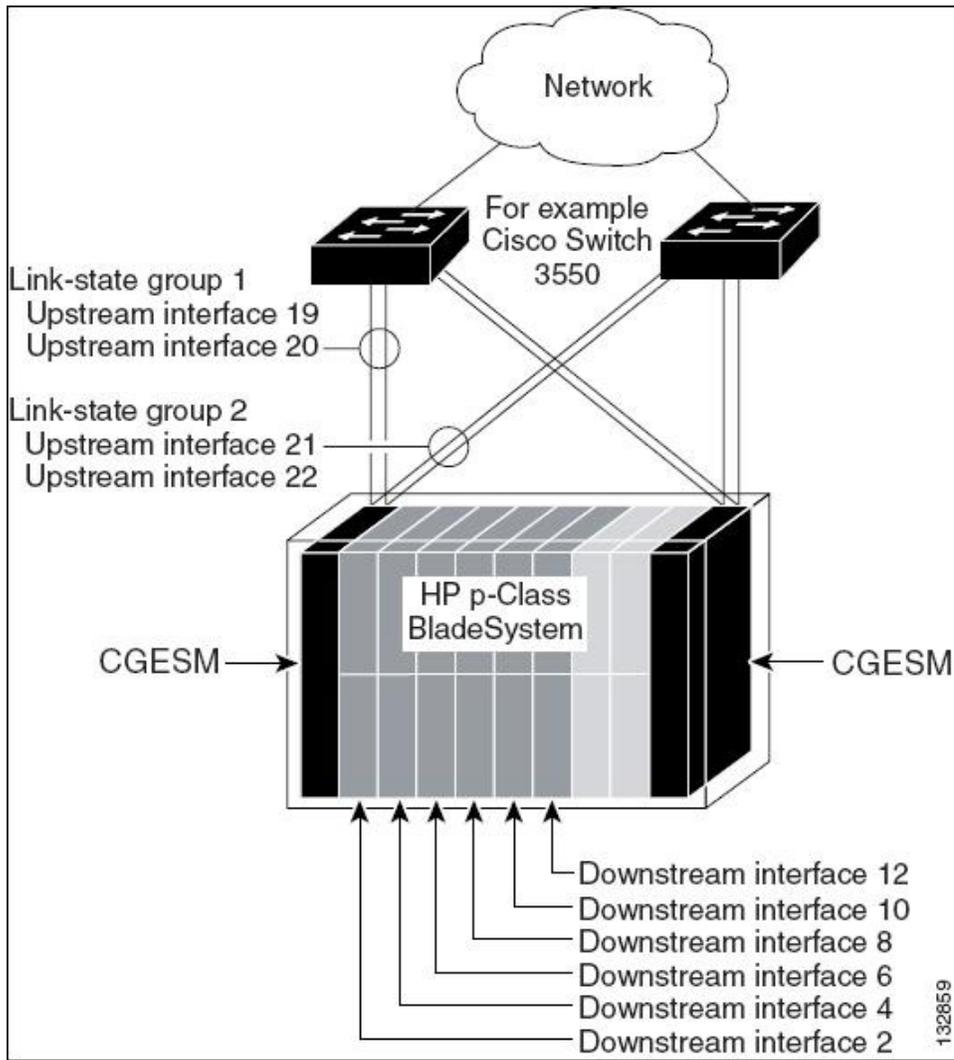
Figure 1 Typical Layer 2 trunk failover configuration

In [Figure 1](#), downstream interfaces 2, 4, and 6 are defined in link-state group 1 with upstream interfaces 19 and 20. Similarly, downstream interfaces 8, 10, and 12 are defined in link-state group 2 with upstream interfaces 21 and 22.

You can recover a downstream interface link-down condition by removing the failed downstream port from the link-state group. You can also enable one of the upstream interfaces in the group to transition to the link-up state. To recover multiple downstream interfaces, disable the link-state group.
