Cisco TelePresence SX, MX, and DX Series

Collaboration Endpoint Software 8

D15314.19

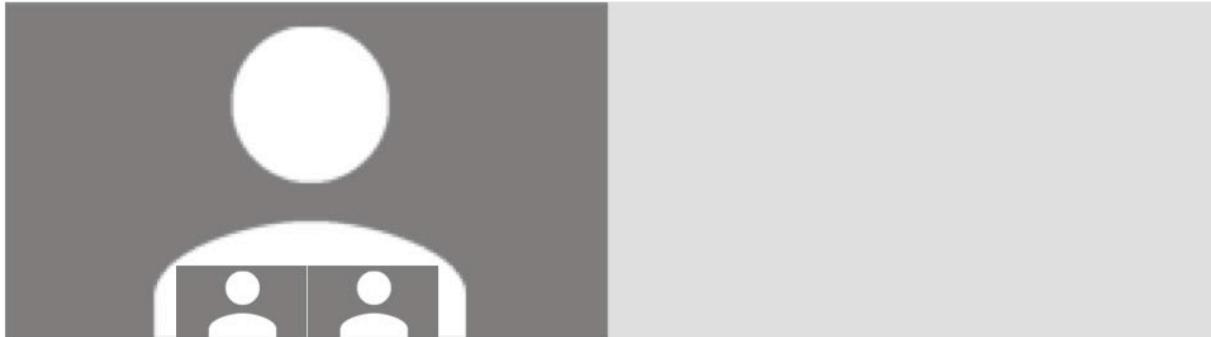
The above example shows a two-screen system in a conference where Multistream is not enabled. The endpoint is receiving only one transcoded stream from the Cisco TelePresence Server.

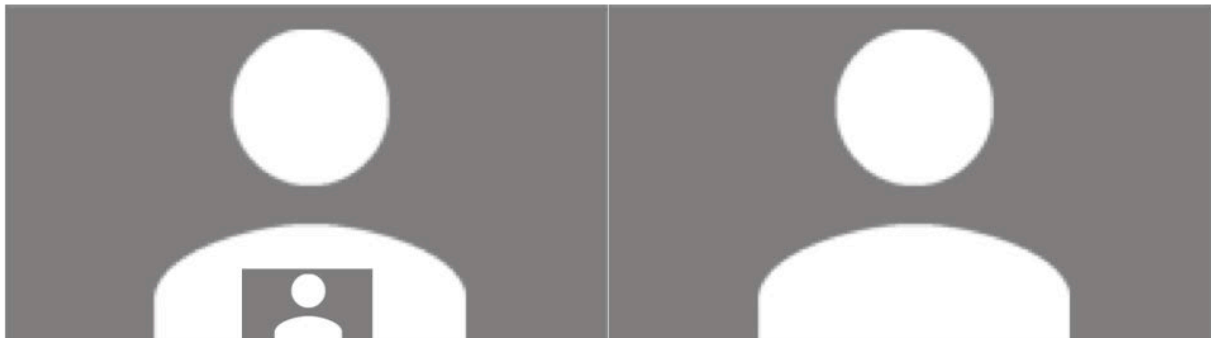
The above example shows the same conference with Multistream enabled.
