Cisco TelePresence SX, MX, and DX Series

Collaboration Endpoint Software 8

D15314.21

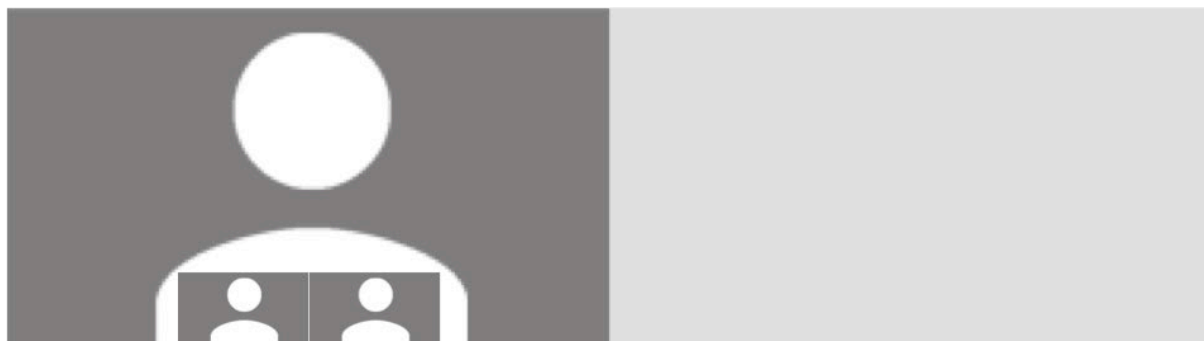
The above example shows a two-screen system in a conference where Multistream is not enabled. The endpoint is receiving only one transcoded stream from the Cisco TelePresence Server.

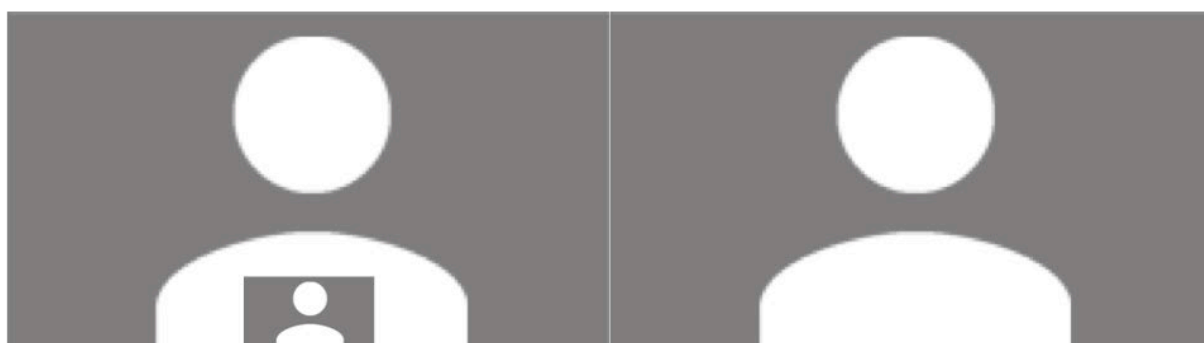
The above example shows the same conference with Multistream enabled.
