Cisco Collaboration Endpoint Software 9

Release notes

D15373.13

January 2018

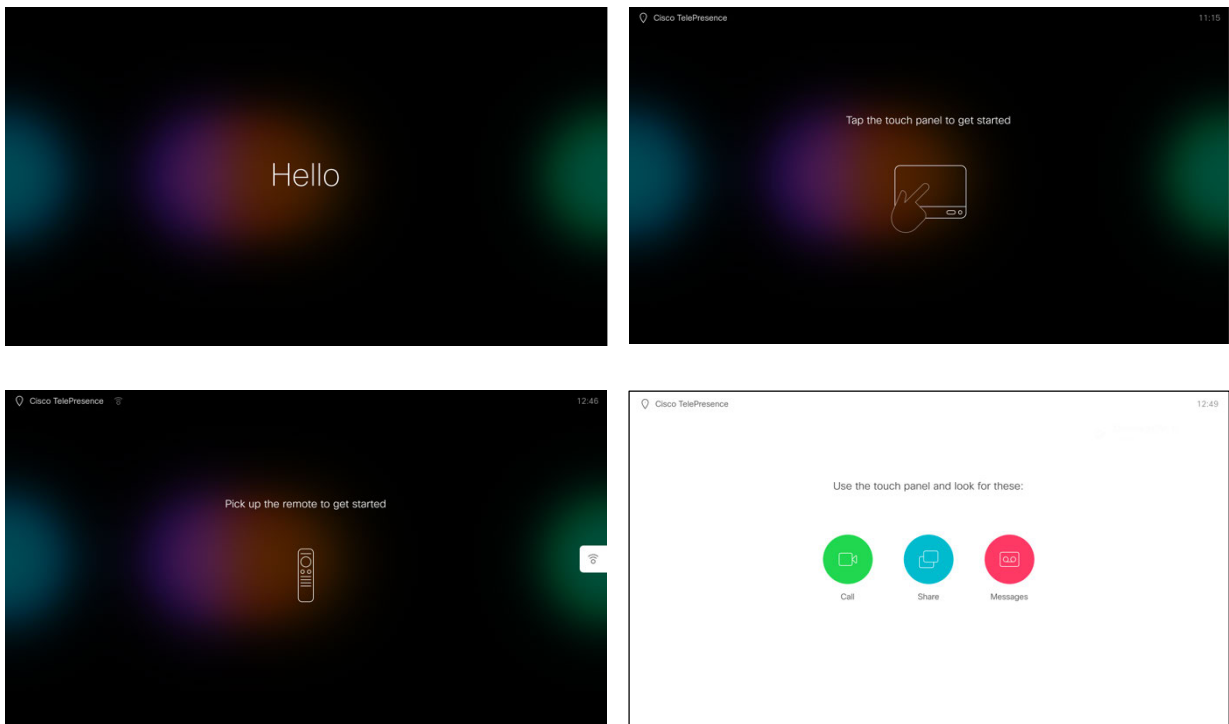
The video system will wake up with a greeting before going into the “Halfwake” state with simple guidance how to get started.

Depending on the system, whether it is controlled by a TRC6 remote control or a Touch 10 panel the guidance text will automatically adapt to the current configuration. If you have a Touch 10 panel connected and wake up the system by tapping the touch screen further guidance will be displayed on-screen instead of the large clock that was displayed in earlier software versions.
