Codec C Series

Software release notes

Software version TC3

D14614 rev. 9

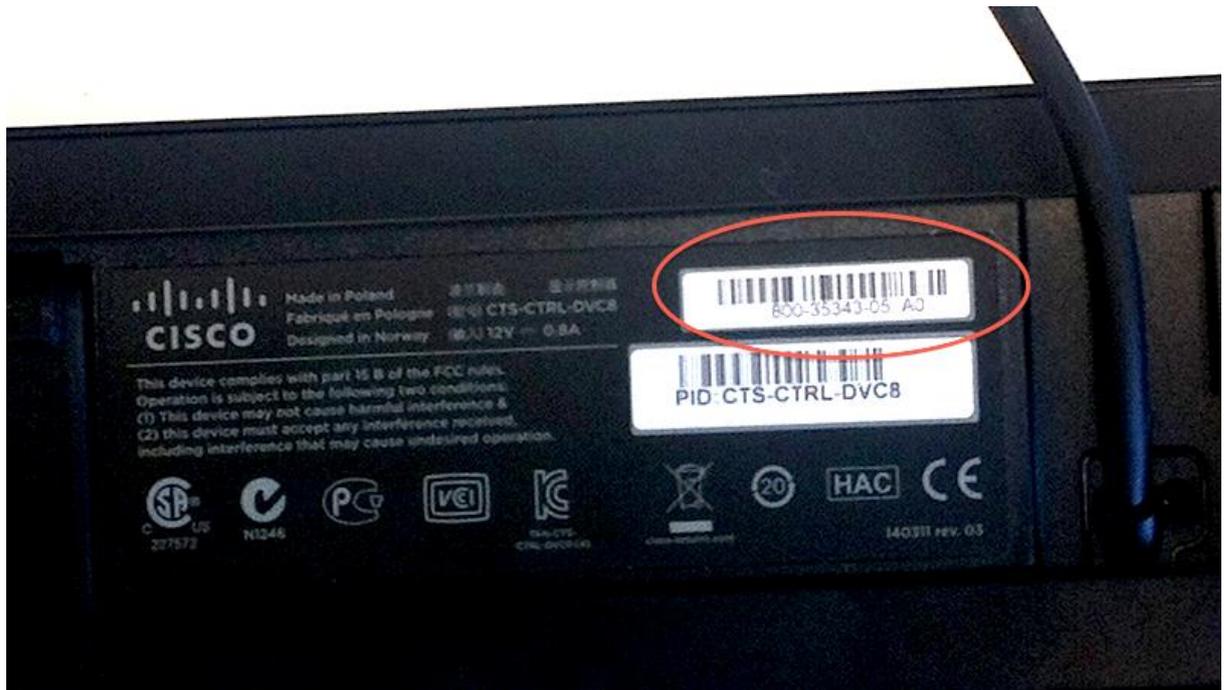
- ▶ The TAN number can be found on the back of the Cisco TelePresence Touch 8 panel on the sticker positioned in the upper right corner.

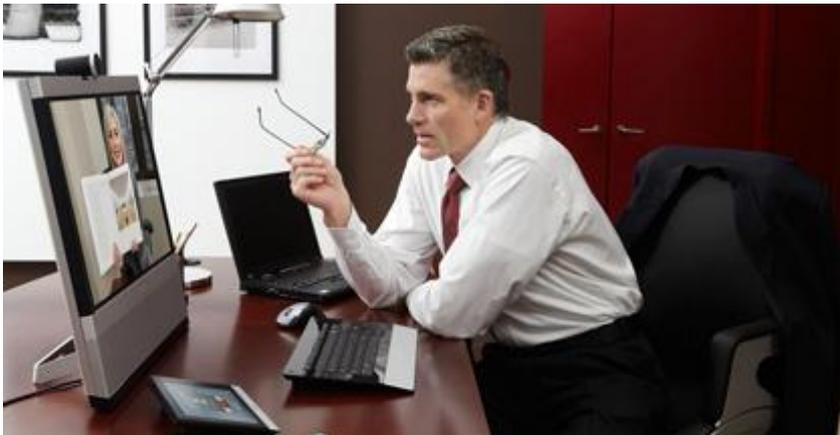
The TC3.1.0 release introduces support for the new TANDBERG EX90. The TANDBERG EX90 revolutionizes personal telepresence...the first with absolute quality 1080p30 video, the easy-to-use inTouch interface and unmatched collaboration. For more information please visit: <http://www.tandberg.com> , where user documentation will be available for download.

Note: The TANDBERG EX90 requires software version TC3.1.0 or later.
