Cisco TelePresence System Codec C/EX/MX-Series

Software release notes TC4

D1475511

October 2012

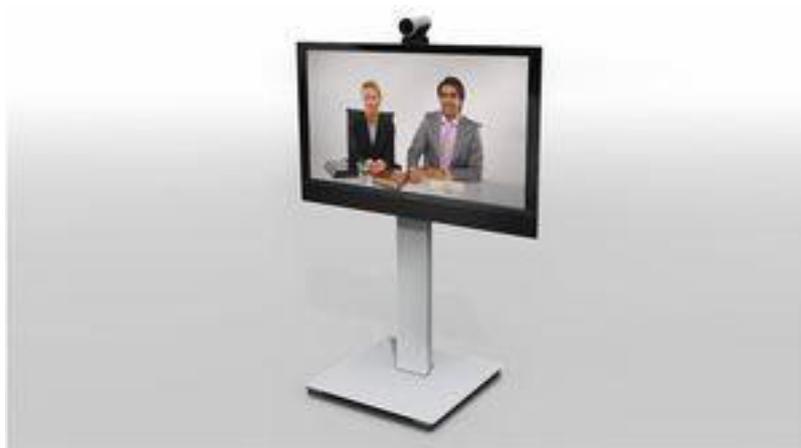
The TC4.2.0 release introduces support for the new Cisco TelePresence MX200.

Cisco TelePresence MX200 is the first truly integrated video endpoint for the meeting room, with a look that everyone wants and can afford, and designed with qualities to make it as easy to use and install as a phone for everyone, every time.

Note: Cisco TelePresence MX200 requires software version TC4.2.0 or later.

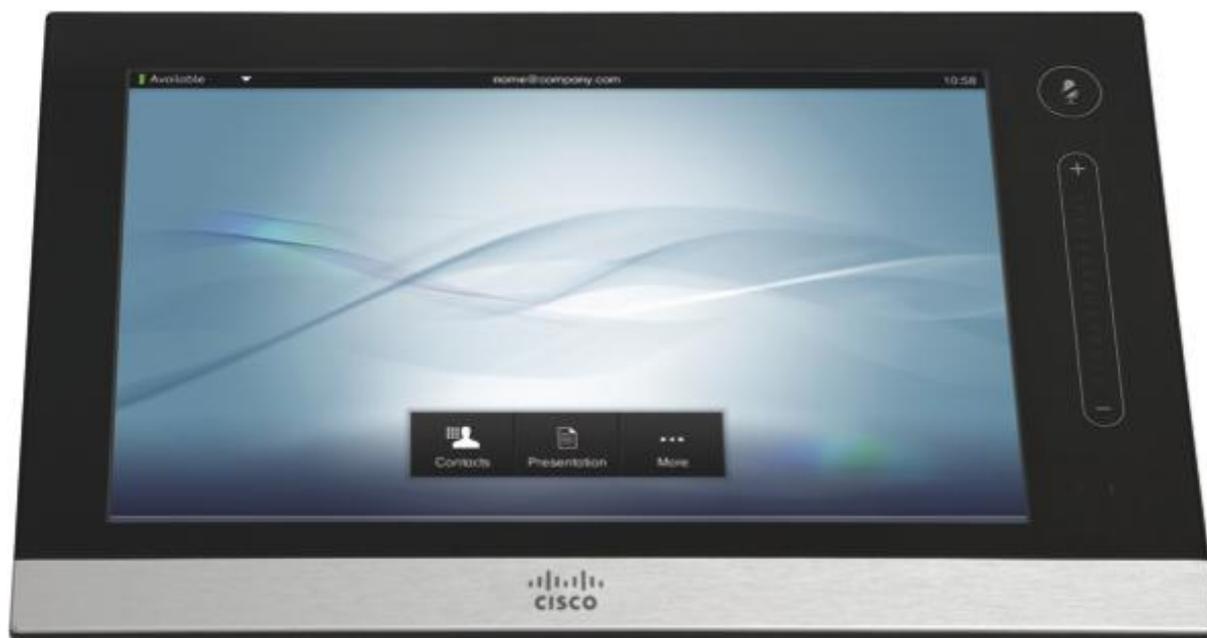
You'll quickly see how easy and effortless it is to use:

- Simple set-up – one cable connection to network
- Reduced learning curve – clear, context-based interaction
- Easy to connect – select from list of video endpoints
- Seamless collaboration – select the device you want to share
- Consistent experience – shared experience with the immersive Telepresence T3/T1

Note: The Cisco TelePresence Touch screen requires software version TC4.1.0 or later.

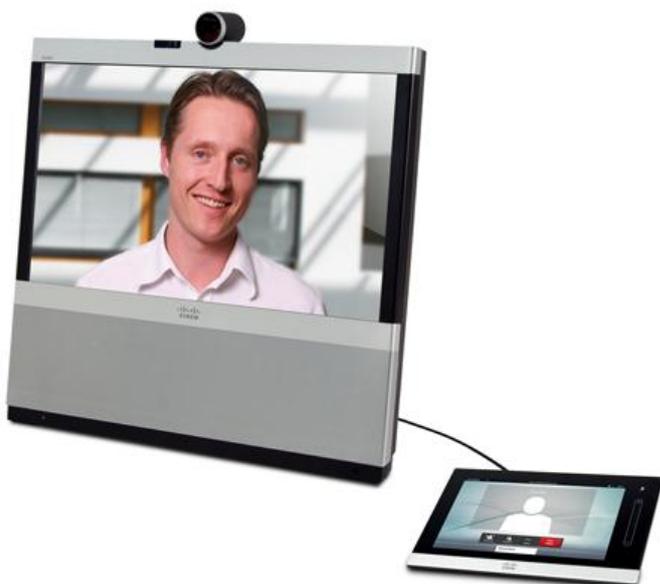
The TC4.0.0 release introduces support for the new Cisco TelePresence System EX60, personal TelePresence for knowledge workers.

The Cisco TelePresence System EX60 is ideal for individual contributors and knowledge workers throughout the organization – bringing the power of TelePresence to the desktop or cubicle as an “always available, anytime” resource.

Note: The Cisco TelePresence System EX60 requires software version TC4.0.0 or later.

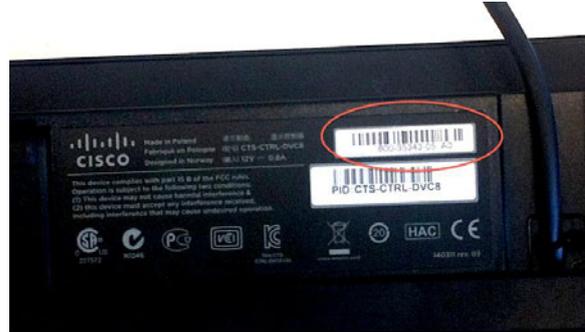
HW dependencies – Compatibility Levels Cisco TelePresence Touch 8

The TAN number can be found on the back of the Cisco TelePresence Touch 8 panel on the sticker positioned in the upper right corner.

Identify the compatibility level of the Touch panel by finding the TAN number in this table.
