# **Cisco TelePresence System C/SX/EX/MX/Profile Series**

Software release notes TC7

D1507136

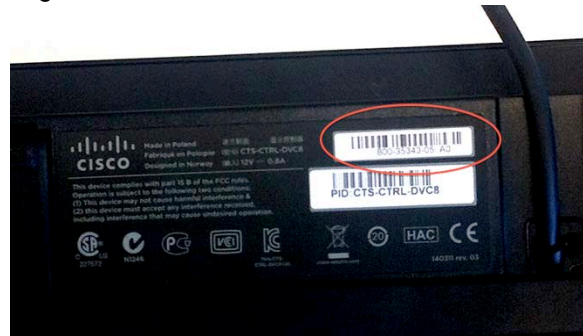
The TAN number can be found on the back of the Cisco TelePresence Touch 8 panel on the sticker positioned in the upper right corner.

Identify the minimum software supported by using the TAN number with this table.
