Cisco IP Video Phone

E20

Software release notes TE4.1.7

D1481010

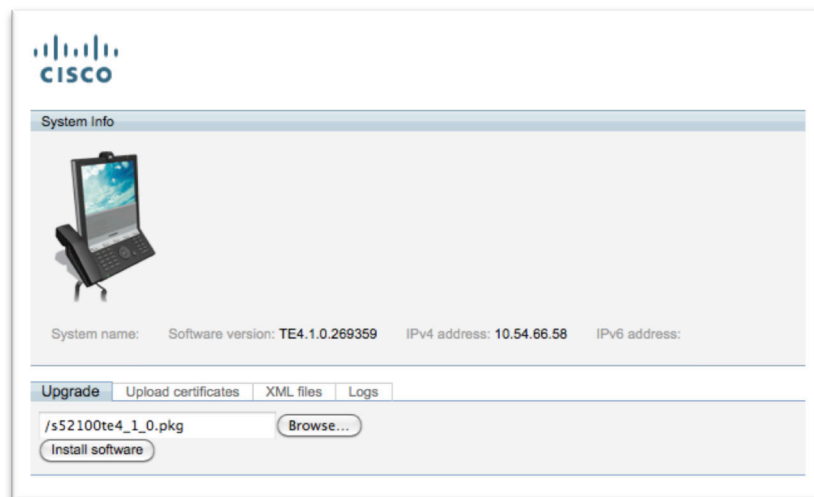
- 1) Download the file to your computer
- 2) Browse to IP address of the E20
- 3) Click **Browse** and locate the file on your computer
- 4) Click **Install Software**
