Cisco TelePresence Server 3.1(1.95)

Software Maintenance Release Notes October 2013

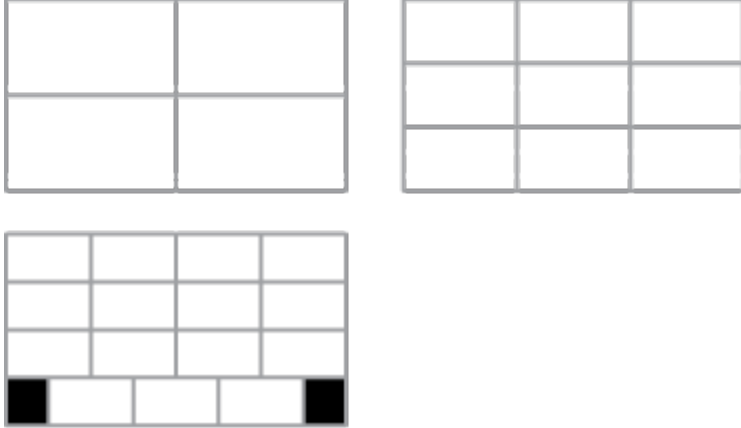
<p><i>Equal</i> layouts show a grid of up to 4, 9, or 16 of the most recent active speakers in equal panes, depending on the number and type of endpoints in the conference. Multi-screen endpoints are displayed together in a horizontal group and may be centered if the grid is wider than the number of screens in the endpoint. This layout is not available on multi-screen endpoints.</p>
