# Cisco TelePresence Server

## 3.1(1.97)

### Software Maintenance Release Notes

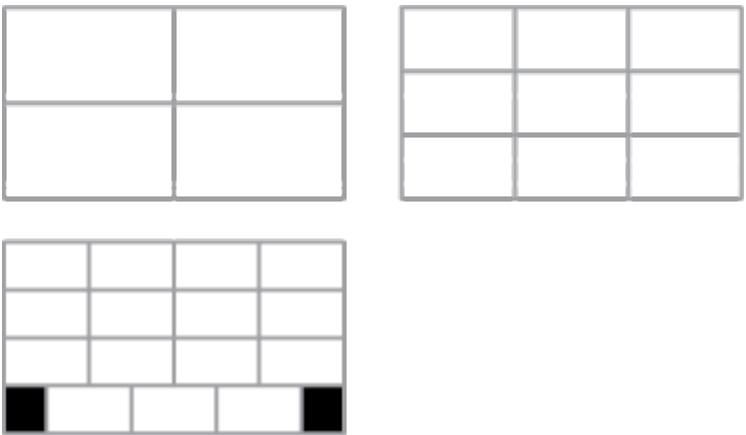
<i>Equal</i> layouts show a grid of up to 4, 9, or 16 of the most recent active speakers in equal panes, depending on the number and type of endpoints in the conference. Multi-screen endpoints are displayed together in a horizontal group and may be centered if the grid is wider than the number of screens in the endpoint. This layout is not available on multi-screen endpoints.
