Cisco RF Gateway 1 Software Release Notes, Release 2.02.21

The Cisco RF Gateway Software Release 2.02.21 contains improvements in VOD stream startup timing and supports the IP-MIB. It now provides the GbE loop-through feature per port-pair with “configurable” redundancy parameters.

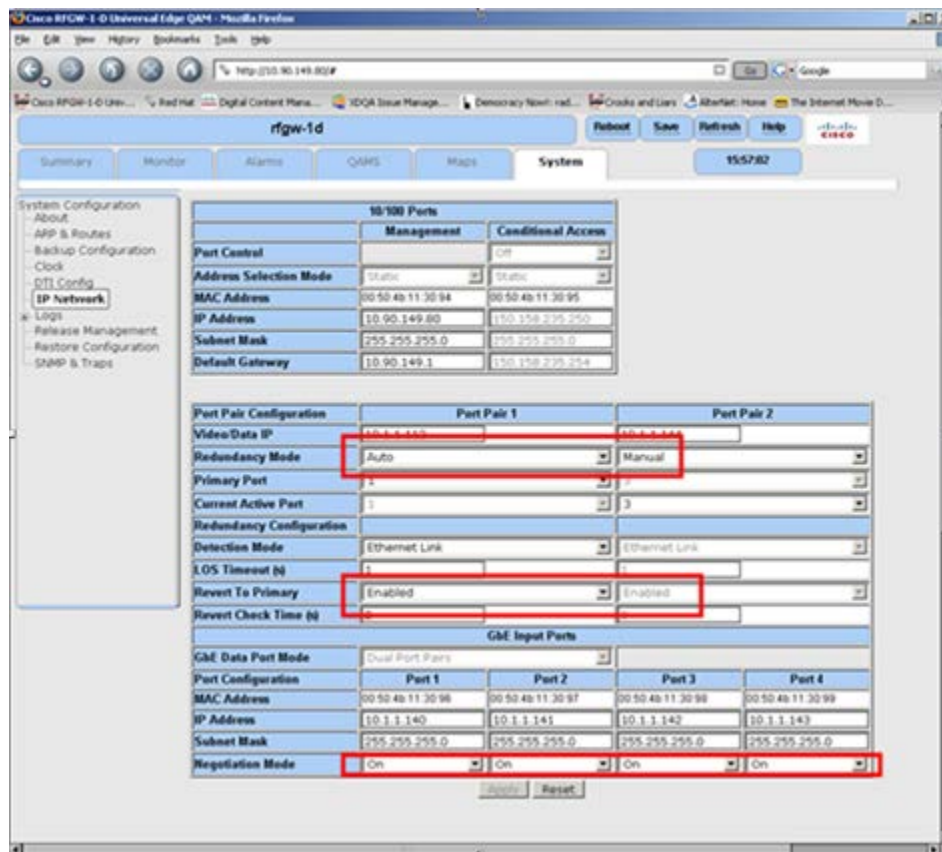
- 1 Launch your web browser.
- 2 In the IP Address field, enter the RF Gateway 1 IP address.
- 3 Click **Enter**.
- 4 Click the *System/IP Network* tab and review the IP settings. Refer to the following screen.
