Cisco RF Gateway 1 Software Release 2.02.24 Release Note

Software Release 2.02.24 fixes seven bugs, two of which may affect output streams.

The purpose of this document is to notify RF Gateway 1 users of the bug fixes, and special upgrade procedures needed for release 2.02.24.

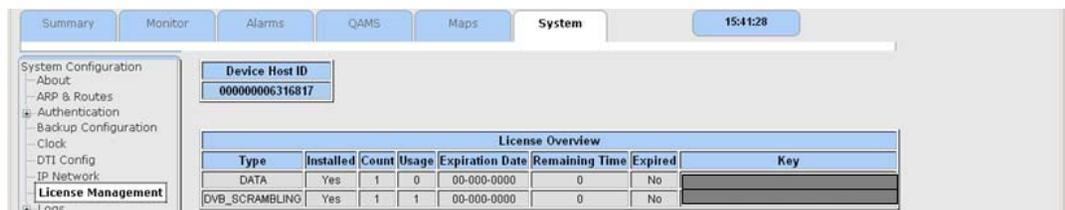
For systems requiring a license upgrade, a licensing capable RF Gateway 1 provides the operator with a new tree menu item, *License Management* located under the **System** tab. See the following screen. The menu provides an FTP mechanism to transfer license files to the device. It is recommended that the operator monitor the file transfer status using feedback from the FTP server.

License Overview							
Type	Installed	Count	Usage	Expiration Date	Remaining Time	Expired	Key
DATA	Yes	1	0	00-000-0000	0	No	
DVB_SCRAMBLING	Yes	1	1	00-000-0000	0	No
